Terrace at Scotts Valley
Scotts Valley Drive at Bean Creek Road
APN 022-162-69

Tree Resource Evaluation/
Construction Impact Assessment/
Tree Protection Plan

Consulting Arborists

Prepared for
Corrie Kates
Scotts Valley Planning Department

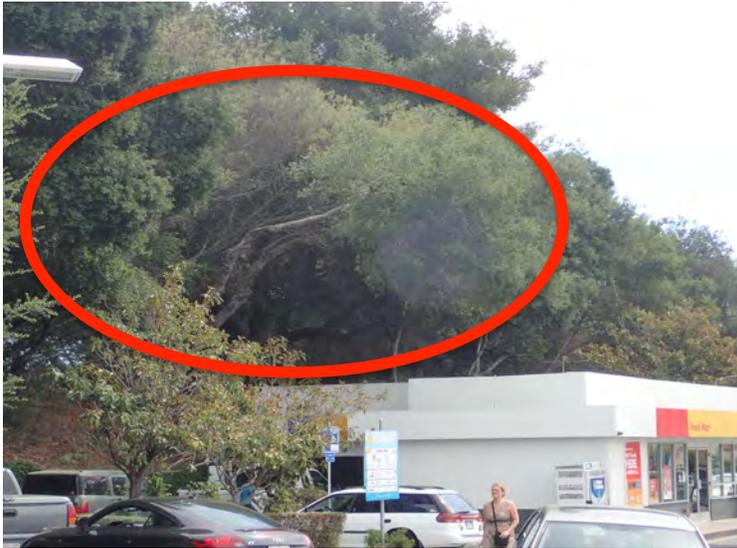
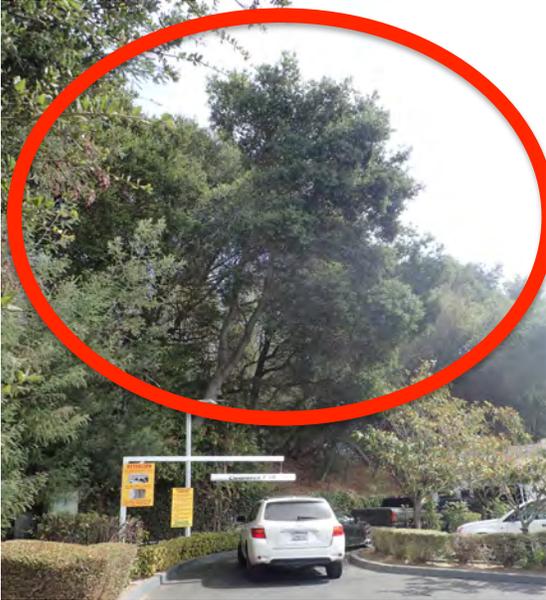
Several of the inventoried trees stand along the southwestern property boundary belonging to the Shell Gas Station and Car Wash.

Many of these trees are in poor condition and unstable due to structural deficiencies, poor pruning practices and suppressed growing conditions. Several of the trees lean dramatically over the area where cars wait to enter and then exit the car wash facility. These trees present a High Risk of falling and injuring people and property.
