**Tree Inventory, Assessment,
and
Protection**

**100 Enterprise Way
Scotts Valley, CA 95063**

CV Scotts Valley 2, Investment, LLC

December 2, 2015

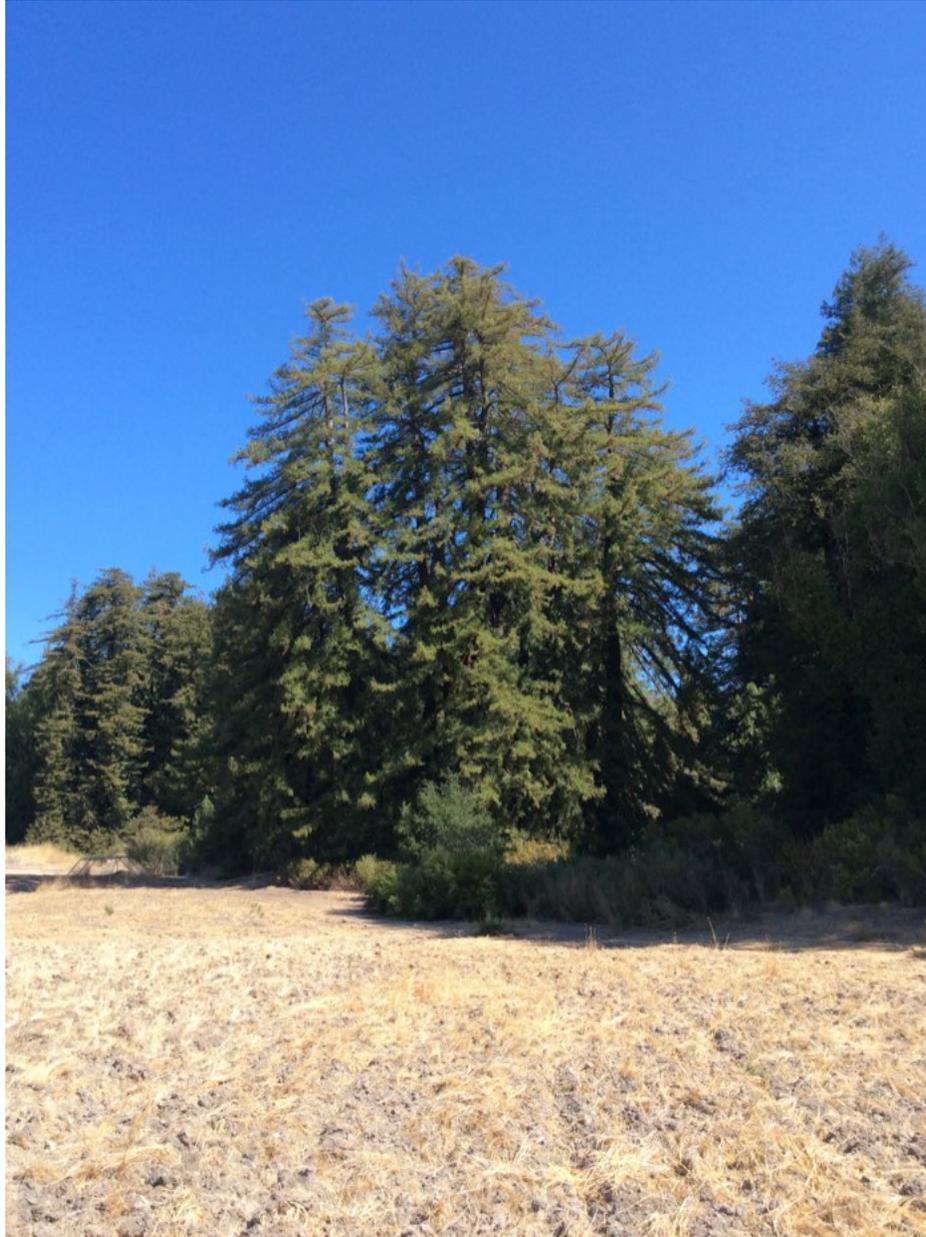
C1: Stand of redwoods #245 to #268

Bay laurels 268 and 262 have significant structural defects and conditions that could lead to failure under normal conditions including multiple stems and signs of a wood decaying pathogen (*Ganoderma applanatum*).

Coast redwood 267 has a corrected lean, is located on the edge of the stand, decayed near its base, and leans over the service road that accesses the area to the developing area to the east. This tree along with bay laurel 268 are within Lennar's road improvement area and could be impacted or caused to be removed by that project. Willows 240 and 241 both have failed trunks that extend over a small fence. Cottonwoods 220, 221, 222, 225, 226, and 227 are all dead.

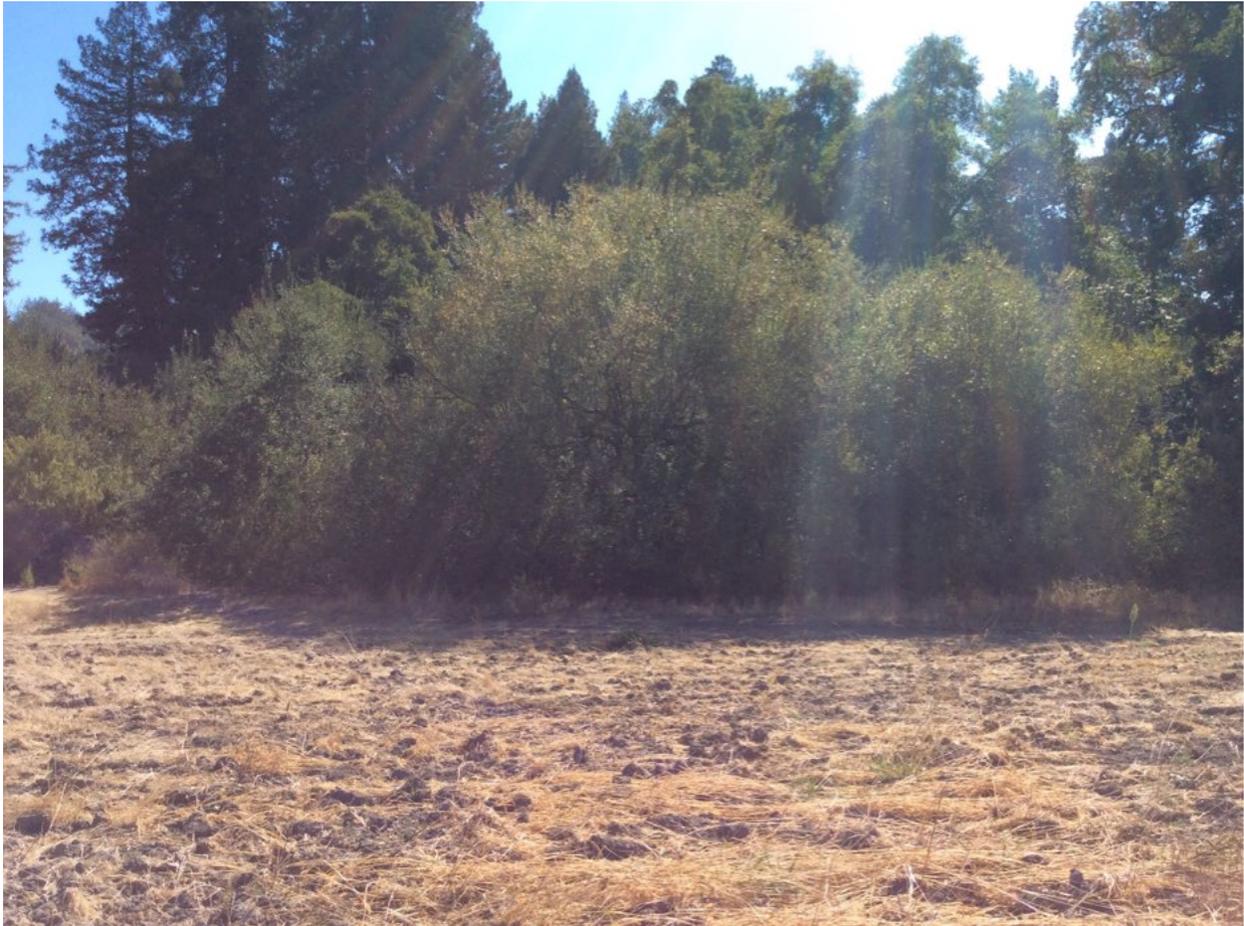
Two willow trees (240 and 241) and one bay laurel (243) are within the project footprint.

C3: Willows #240 and #241 in dense thicket

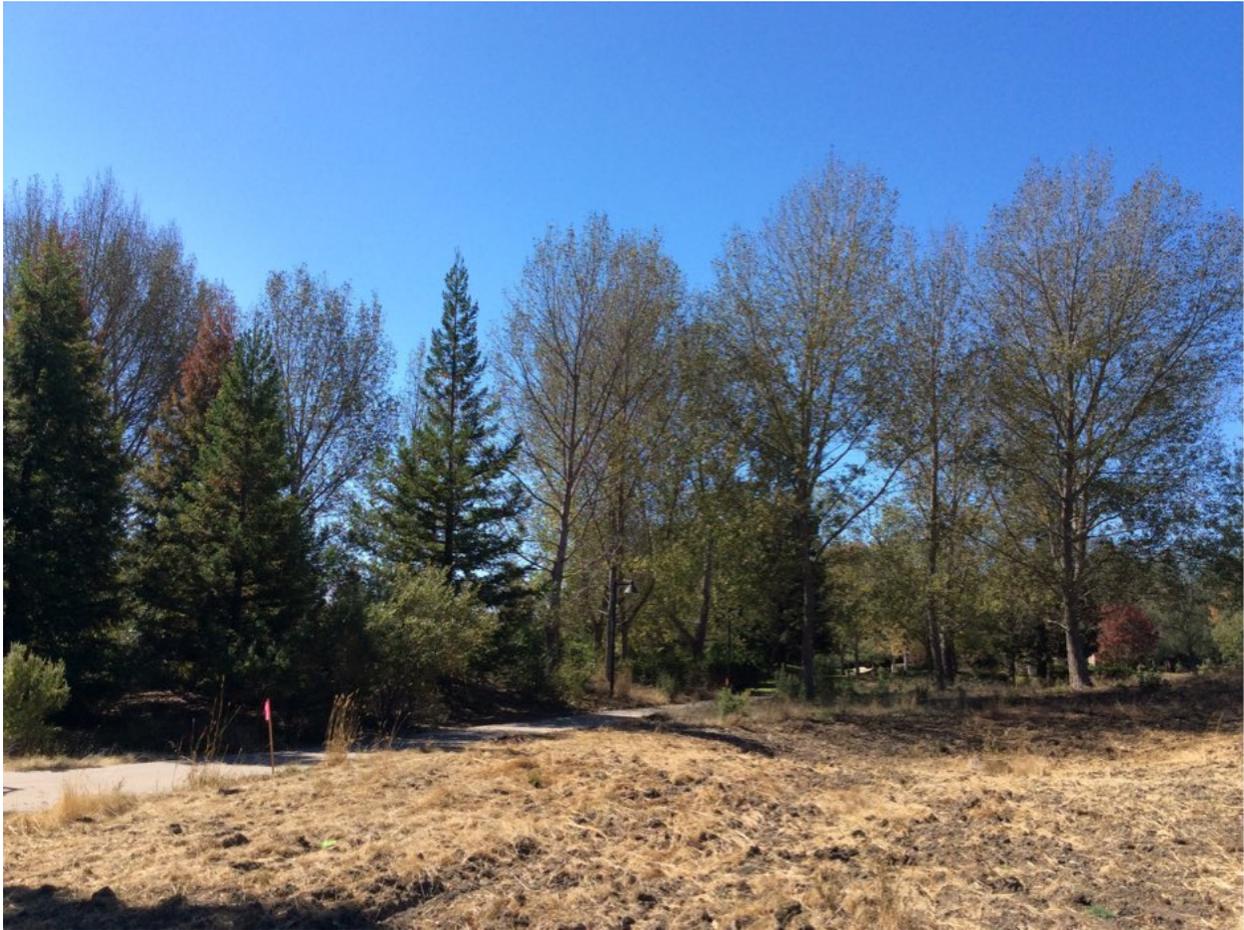
C4: Cottonwoods #230 to #231 and redwood #232 on Enterprise Tech
