INITIAL STUDY

Gateway South Office Building and Fire Station

September 16, 2002

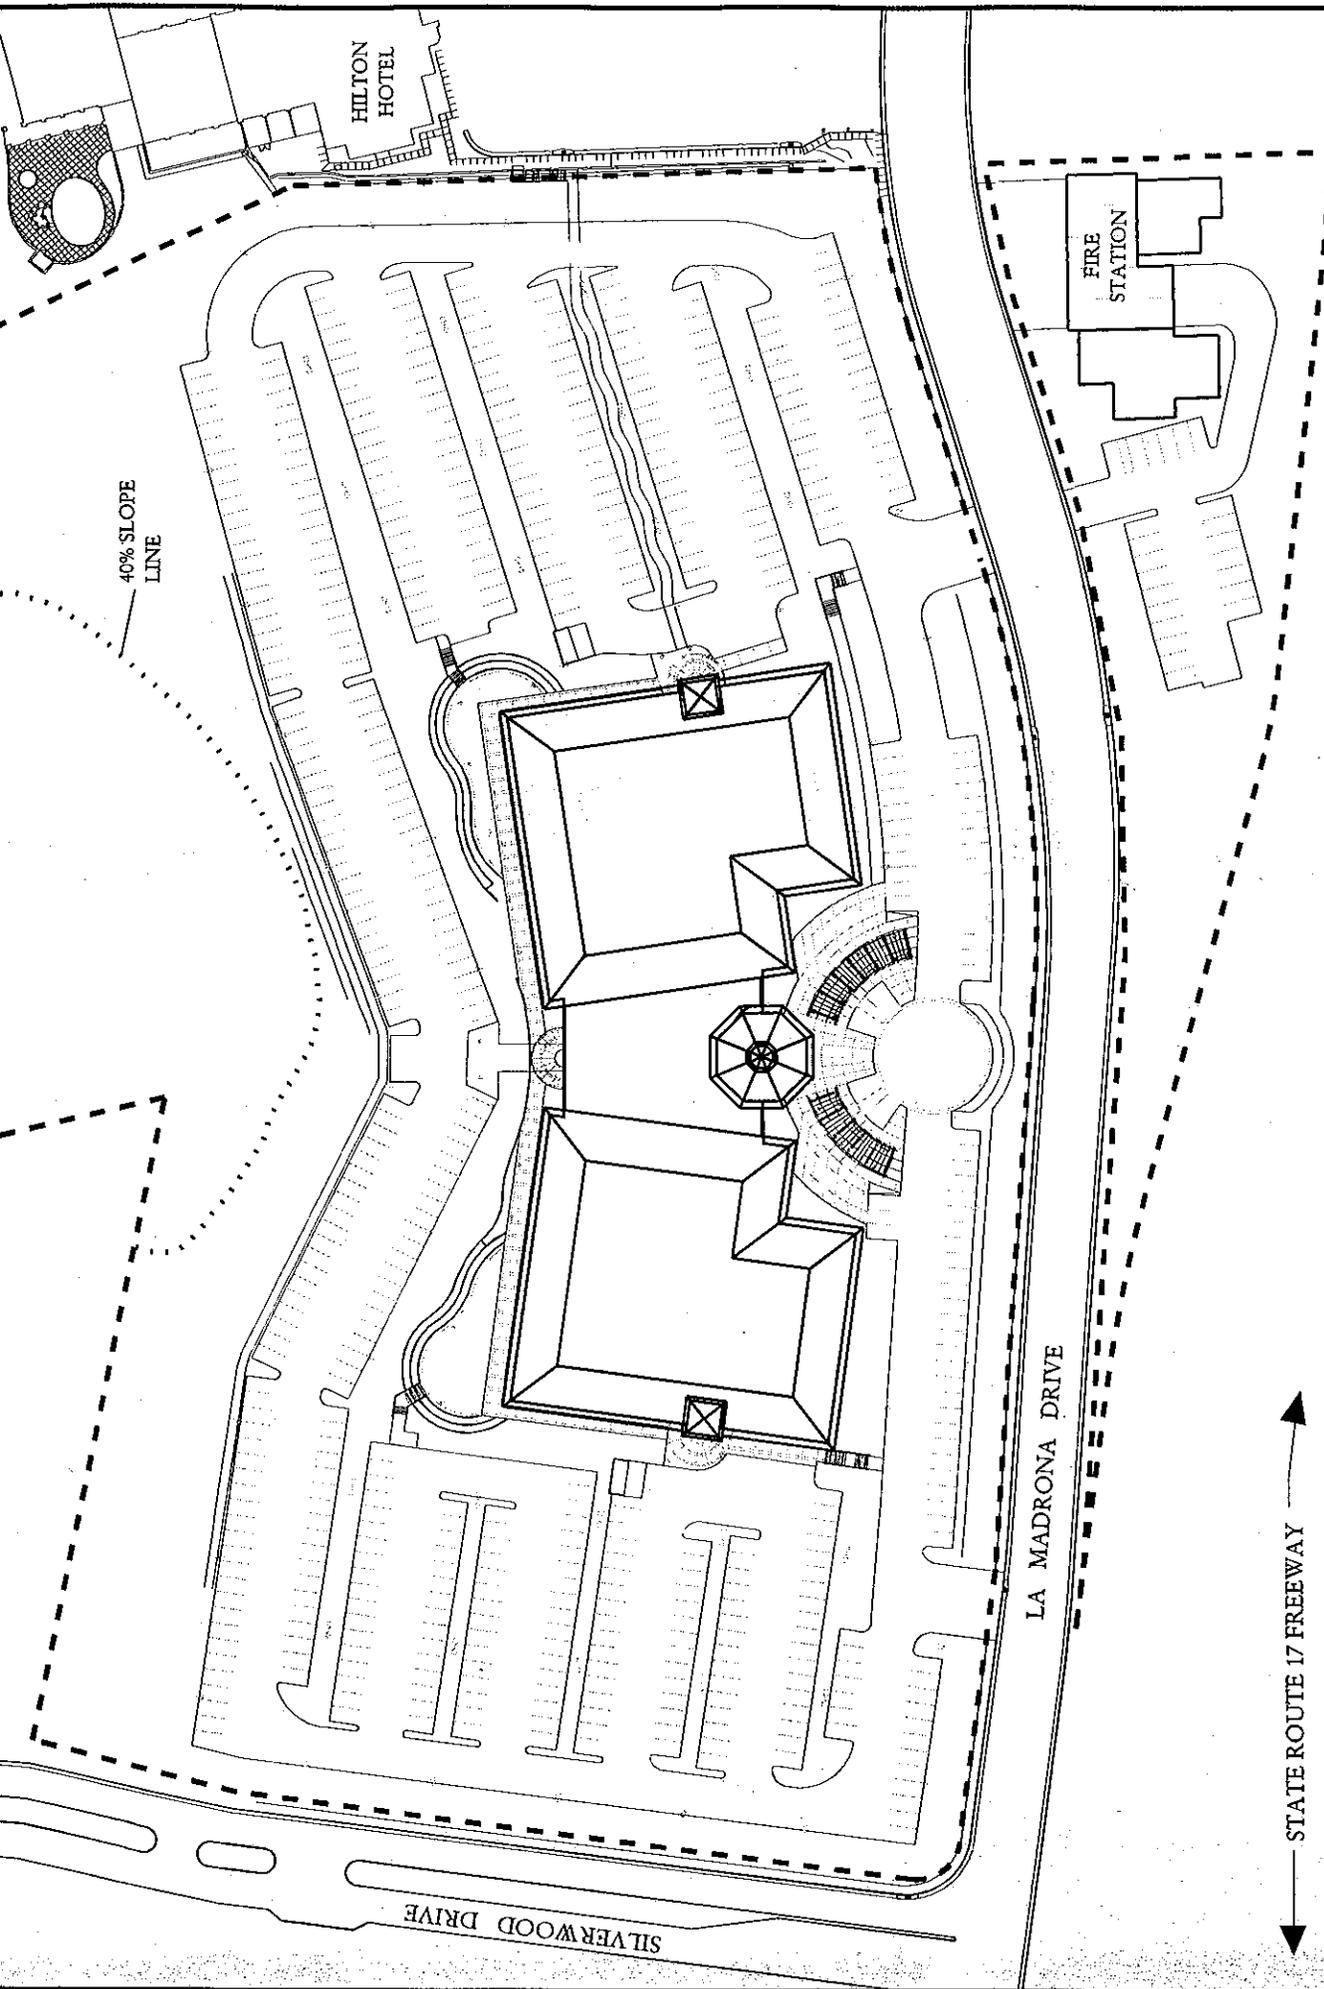
FIGURE 2: SITE MAP
 Gateway South Office Building
 and Fire Station
 Scotts Valley, CA

Parking areas would surround the building on all sides, providing parking for approximately 550 automobiles, including 10 handicap spaces (see Figure 2, Site Plan). Two access driveways leading to the parking areas would be located on La Madrona Drive. Parking areas would be a series of interconnected lots with an internal loop road on the periphery. A pedestrian bridge would connect the upper parking lot on the west side of the building to the second floor of the west-facing, façade, through a rear entrance doorway. A pedestrian walkway through the parking lot would connect the office building property with the adjacent Hilton Hotel property, located immediately to the north of the site.

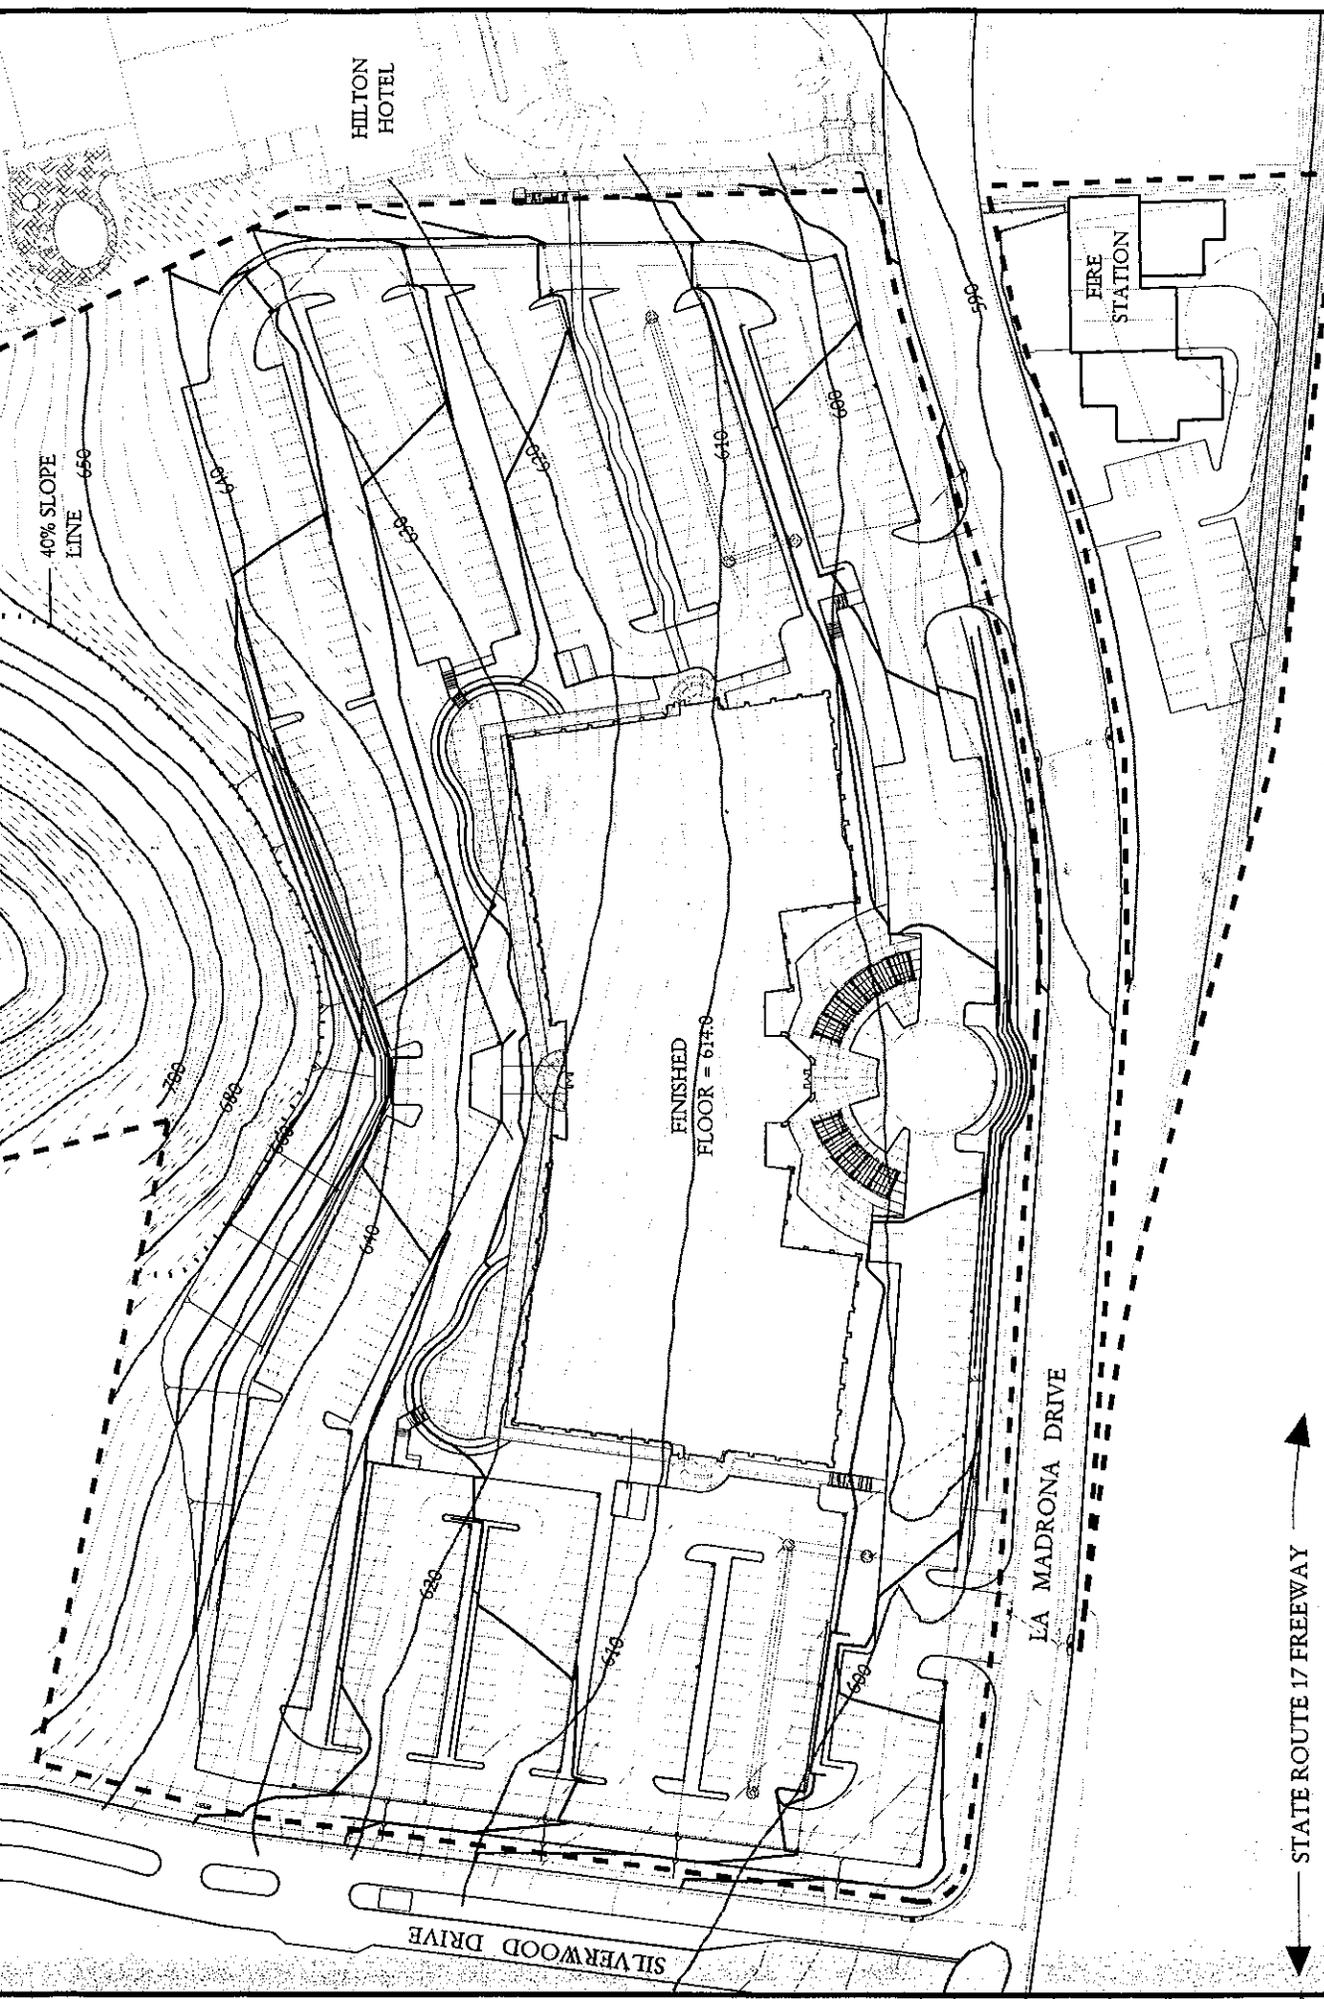
FIGURE 3: GRADING PLAN
 Gateway South Office Building
 and Fire Station
 Scotts Valley, CA

The site would be graded to accommodate the building pad and parking areas (see Figure 3, Grading Plan). Building and parking area pads would be terraced into the slope. Slopes on the developable portion of the site range from 0% to 39%, sloping generally from west to east. Development would be concentrated on the lower, flatter portions of the site. Estimated earthwork quantities include approximately 50,000 cubic yards (cy) of excavated soils, approximately 60,500 cy of fill, of which approximately 10,500 cy would be imported soils. Concrete retaining walls would be utilized in various locations around the property, including the front (east) elevation along La Madrona Drive between the road and the first parking area, between the first and second

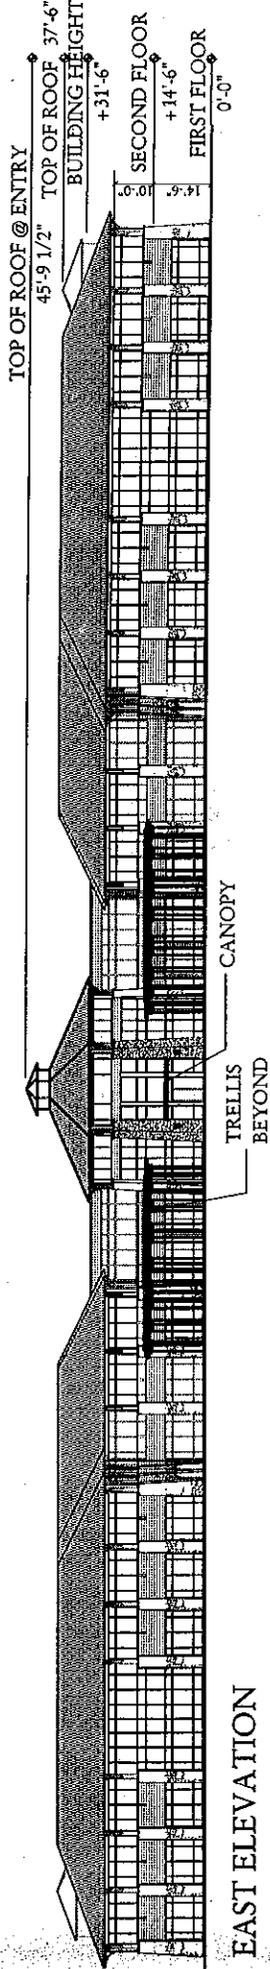
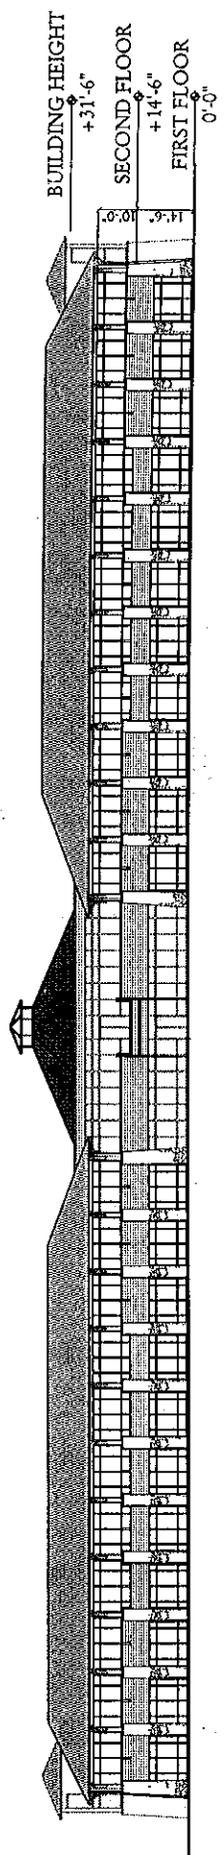
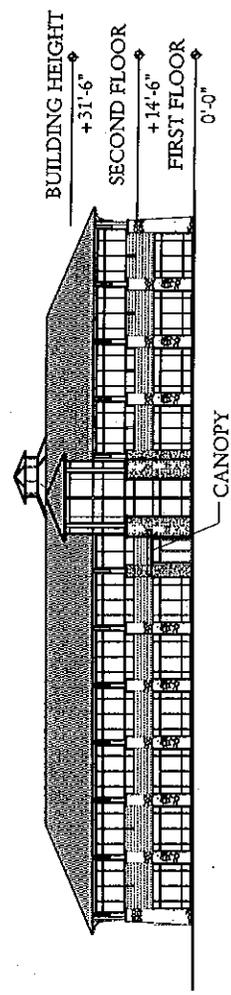
FIGURE 4: ELEVATIONS

Although designs are preliminary, project plans call for a two-story building approximately 136,000 square feet (sq. ft.) constructed with a steel structure on a poured concrete slab. Exterior details would include pilasters clad in stone, stained horizontal wood spandrels, tinted glazing in anodized aluminum window frames, and wooden eave brackets (see Figure 4, Elevations). The hipped parapet roof would be clad in composite slate roofing. The building would be approximately 460 feet long, 190 feet wide, approximately 38 feet tall to the top of the roof (main portion), and approximately 46 feet tall to the peak of the entrance portion of the roof.

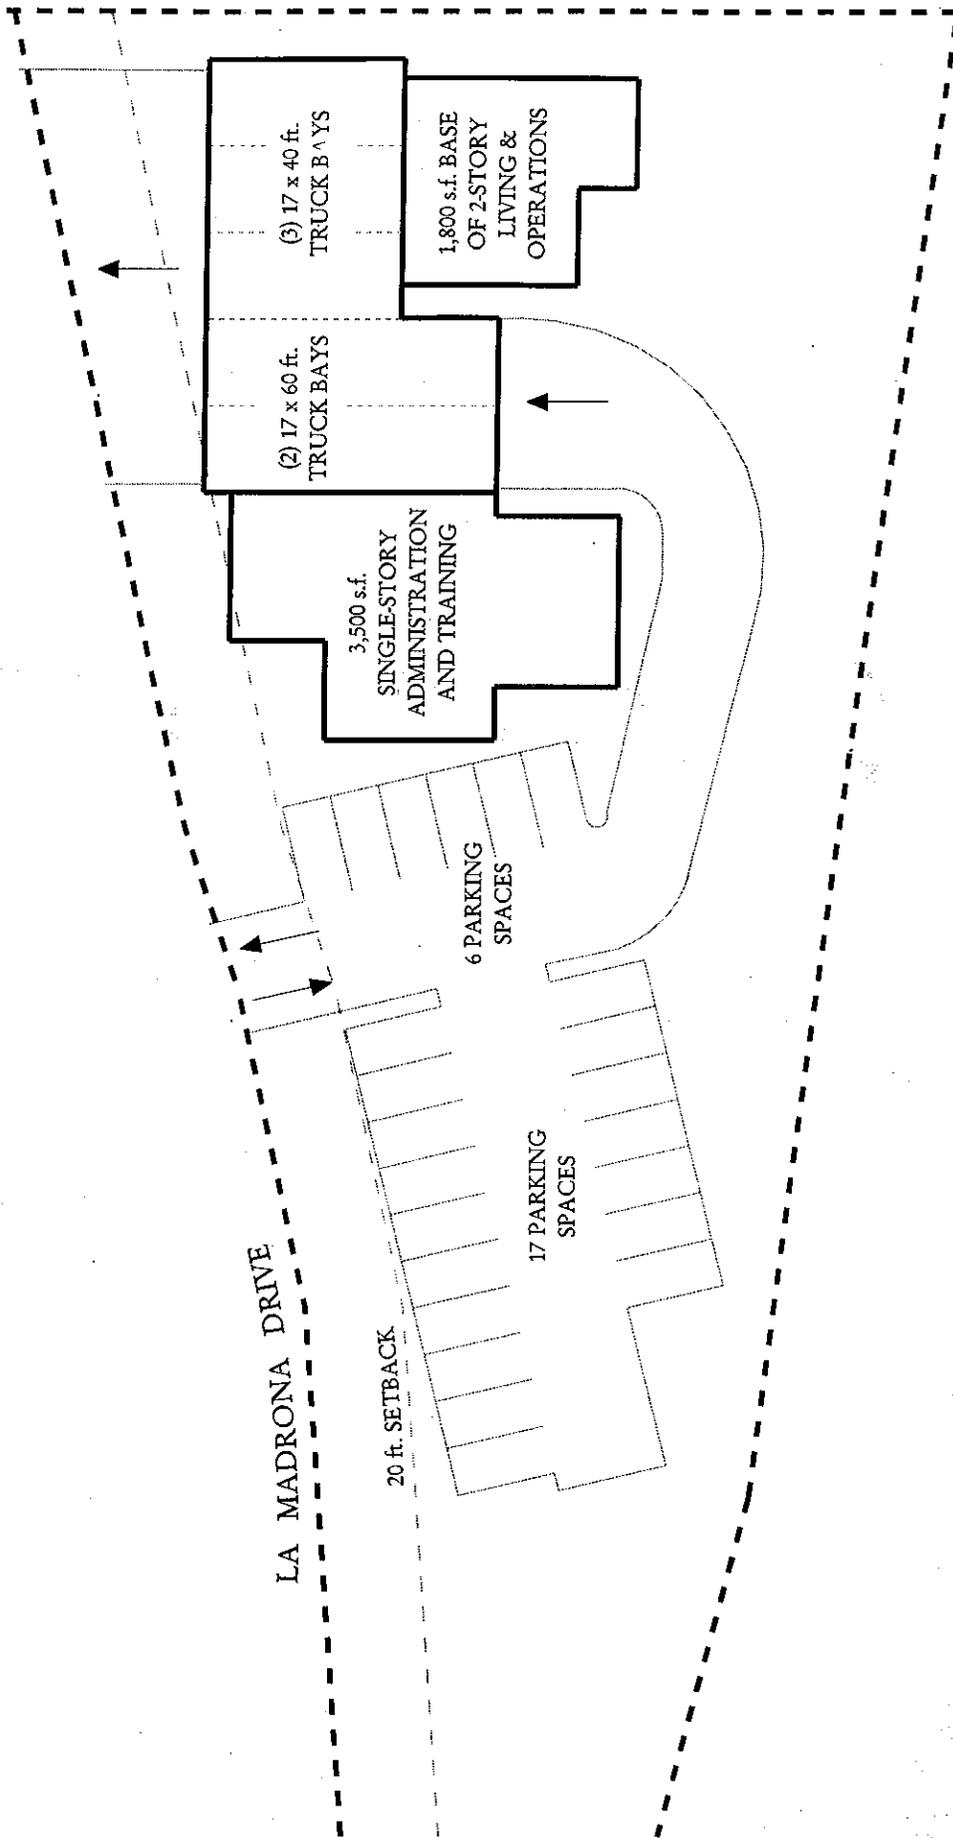
**FIGURE 6: FIRE STATION
SITE PLAN**
Gateway South Office Building
and Fire Station
Scotts Valley, CA

The proposed fire station would be located to the east of the office development on a 1.5-acre site known as the "teardrop" parcel, between La Madrona Drive and the State Highway 17 southbound on-ramp (See Figure 6). This parcel has been sold by the developer of the office building project to the Scotts Valley Fire District who would eventually develop a fire station on the site. Although site plans for the fire station are preliminary, the project would include a single-story administration and training building, a two-story living quarters and operations building, five fire truck bays, and 23 parking spaces, including two handicap spaces. The building footprint would be approximately 9,500 sq. ft., with a total gross building area of approximately 12,000 sq. ft. The building would be located on the northern end of the parcel with parking on the southern end. Access to the site for both fire trucks and automobile parking would be from La Madrona Drive, with a loop driveway for returning fire trucks at the rear of the building to avoid the longer fire trucks from having to back into the truck bays from La Madrona Drive (see Figure 6).

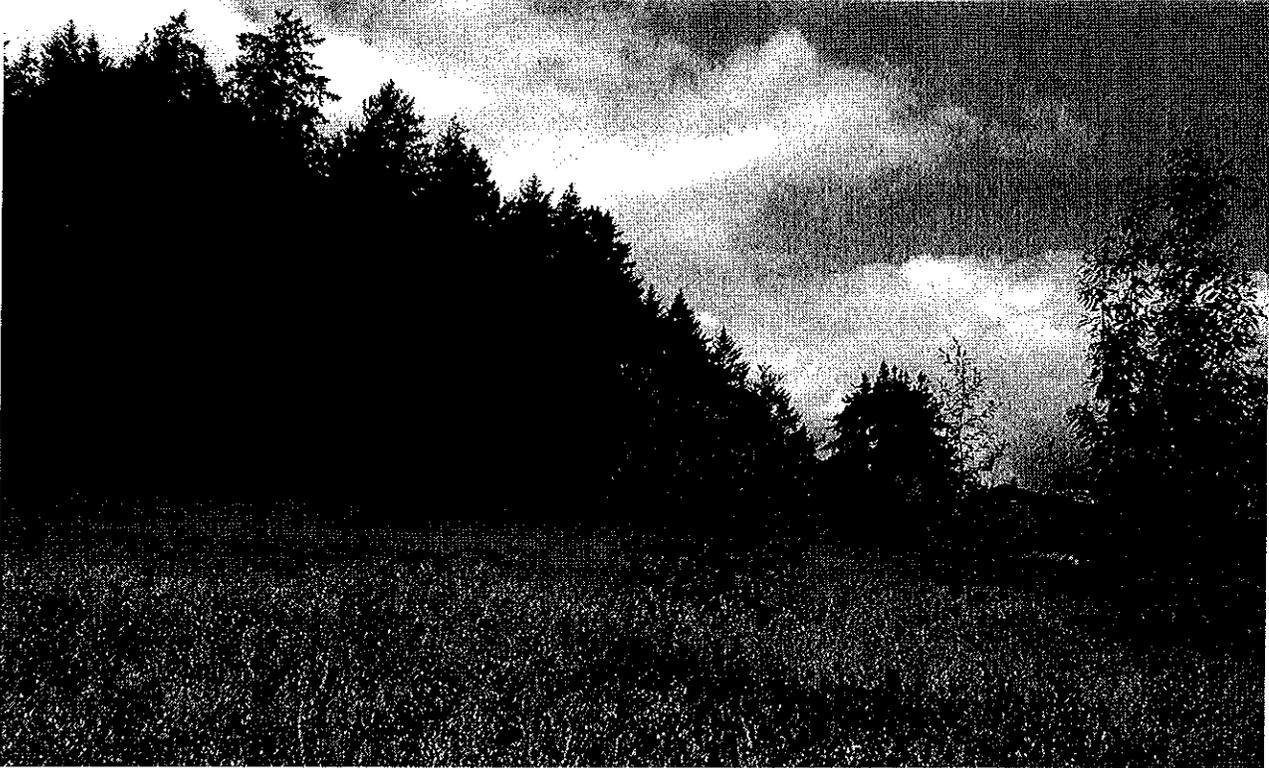
Photo 1: Photo looking west with Hotel in background. Note the annual grasslands in the foreground and forest on the hillside above.

The annual grassland habitat type is found on the lower slopes of the site (Appendix B, Photo 1). The vegetation of this series includes native and non-native species of grasses and annuals. Non-native plant species found in this series includes Bermuda grass (*Cynodon dactylon*), Italian ryegrass (*Lolium multiflorum*), and French broom (*Genista monspessulana*). Native plant species observed includes California poppy (*Eschscholzia californica*), purple needlegrass (*Nassella pulchra*), and California brome (*Bromus carinatus*) (Appendix C, Table 1).

Within the project area, the mixed forest habitat type is found almost exclusively on slopes greater than 40 percent (Appendix A, Figure 2 and Appendix B, Photo 1), with the exception of two large coast live oaks (*Quercus agrifolia* var. *agrifolia*.) and a stand of Coastal redwoods (*Sequoia sempervirens pterophyta*) (Appendix B, Photo 2). The mixed forest habitat located on the site consists of dense stands of: coast live oak, coastal redwood, ponderosa pine (*Pinus ponderosa*), Douglas fir (*Pseudotsuga menziesii*), and California bay (*Umbellularia californica*). The vegetative ground cover within the areas of mixed forest includes poison oak (*Toxicodendron diversilobum*), and fountain miners-lettuce (*Montia Fontana*).

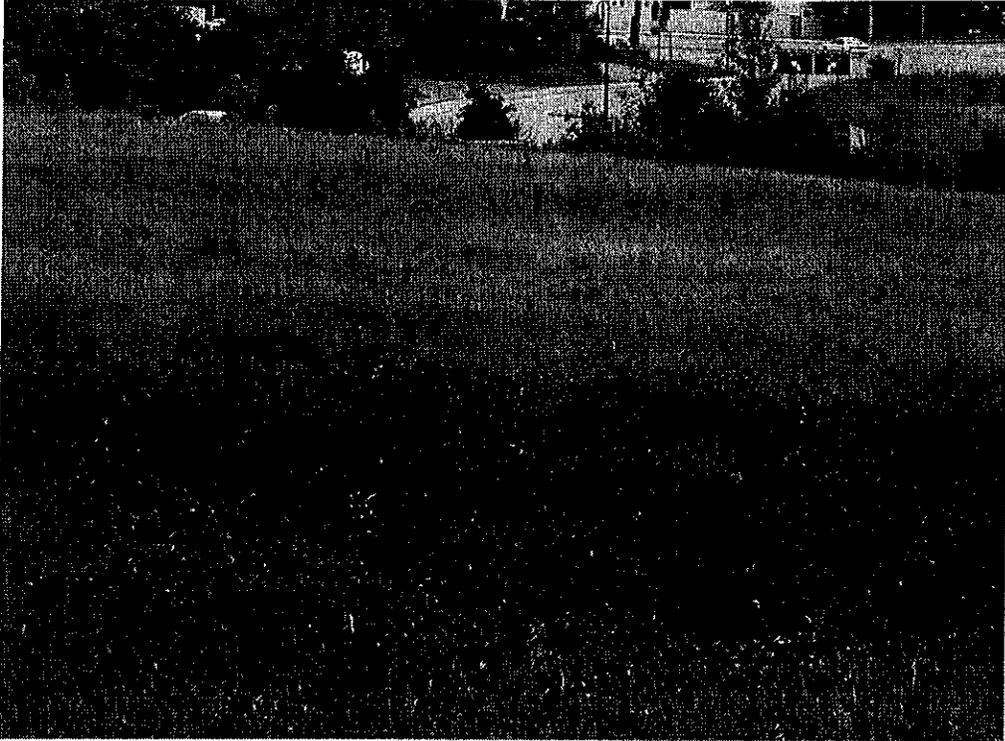
Photo 3: Photo showing one of many freshwater seeps on the upper slopes of the Gateway Office Building Site.

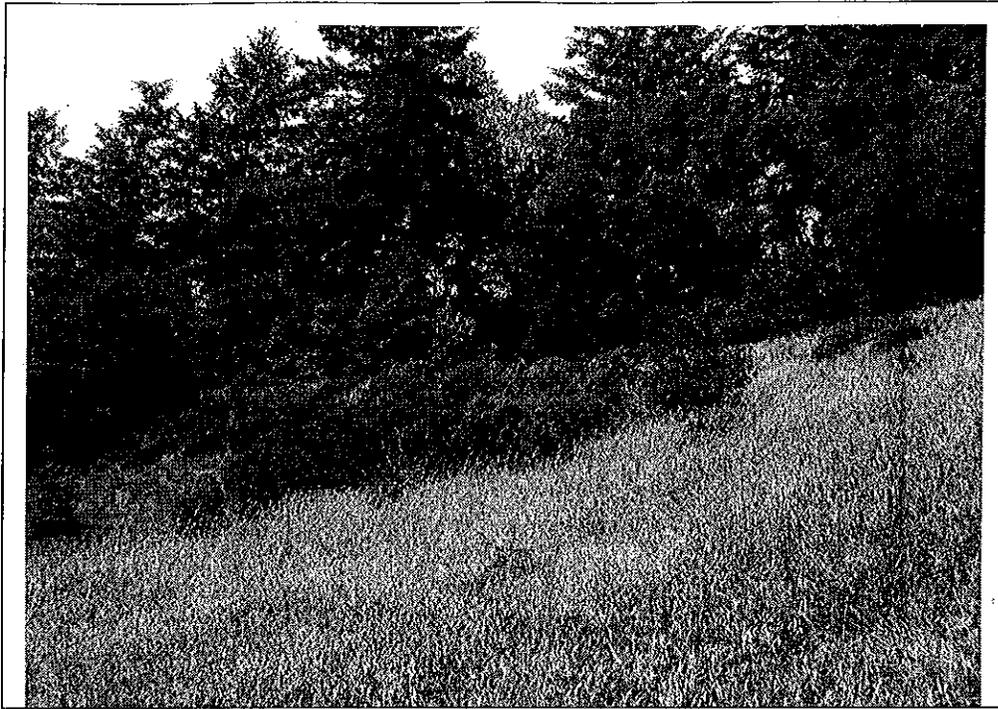
Photo 1. Mixed coniferous forest located on the upper slopes of the Gateway South Office Building Site.

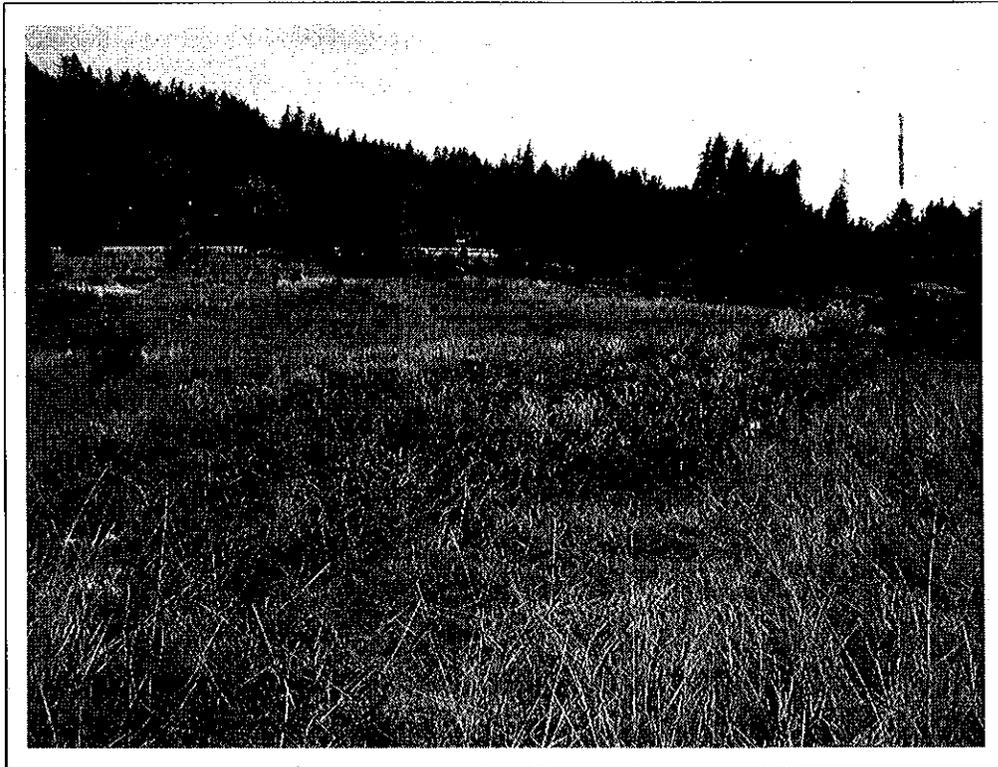
Photo 2. View of seasonal wetland looking southeast towards La Madrona Road. This seasonal wetland is the location of data point 3.

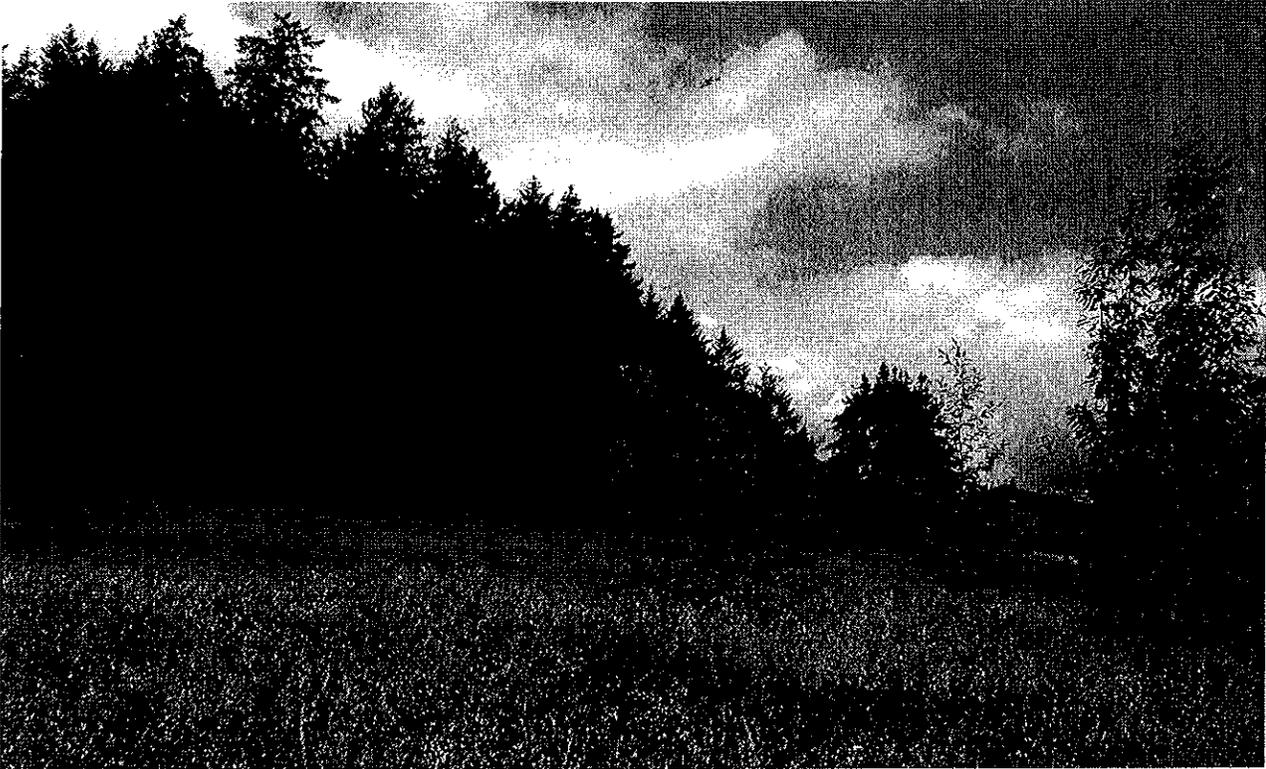
Photo 1: Photo looking west with Hotel in background. Note the annual grasslands in the foreground and forest on the hillside above.

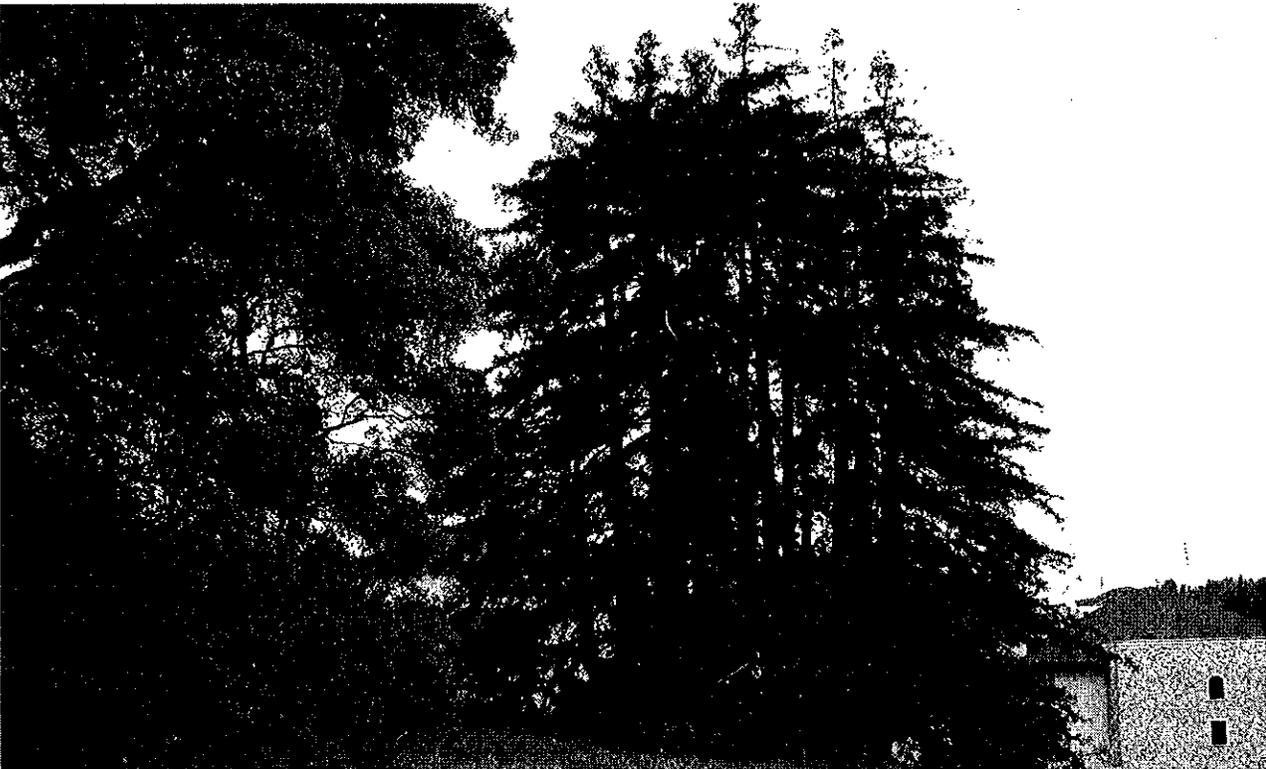
Photo 2: One of two large Coast Live Oaks and a cluster of Coastal redwoods that may potentially be impacted by the Gateway South Office Building.

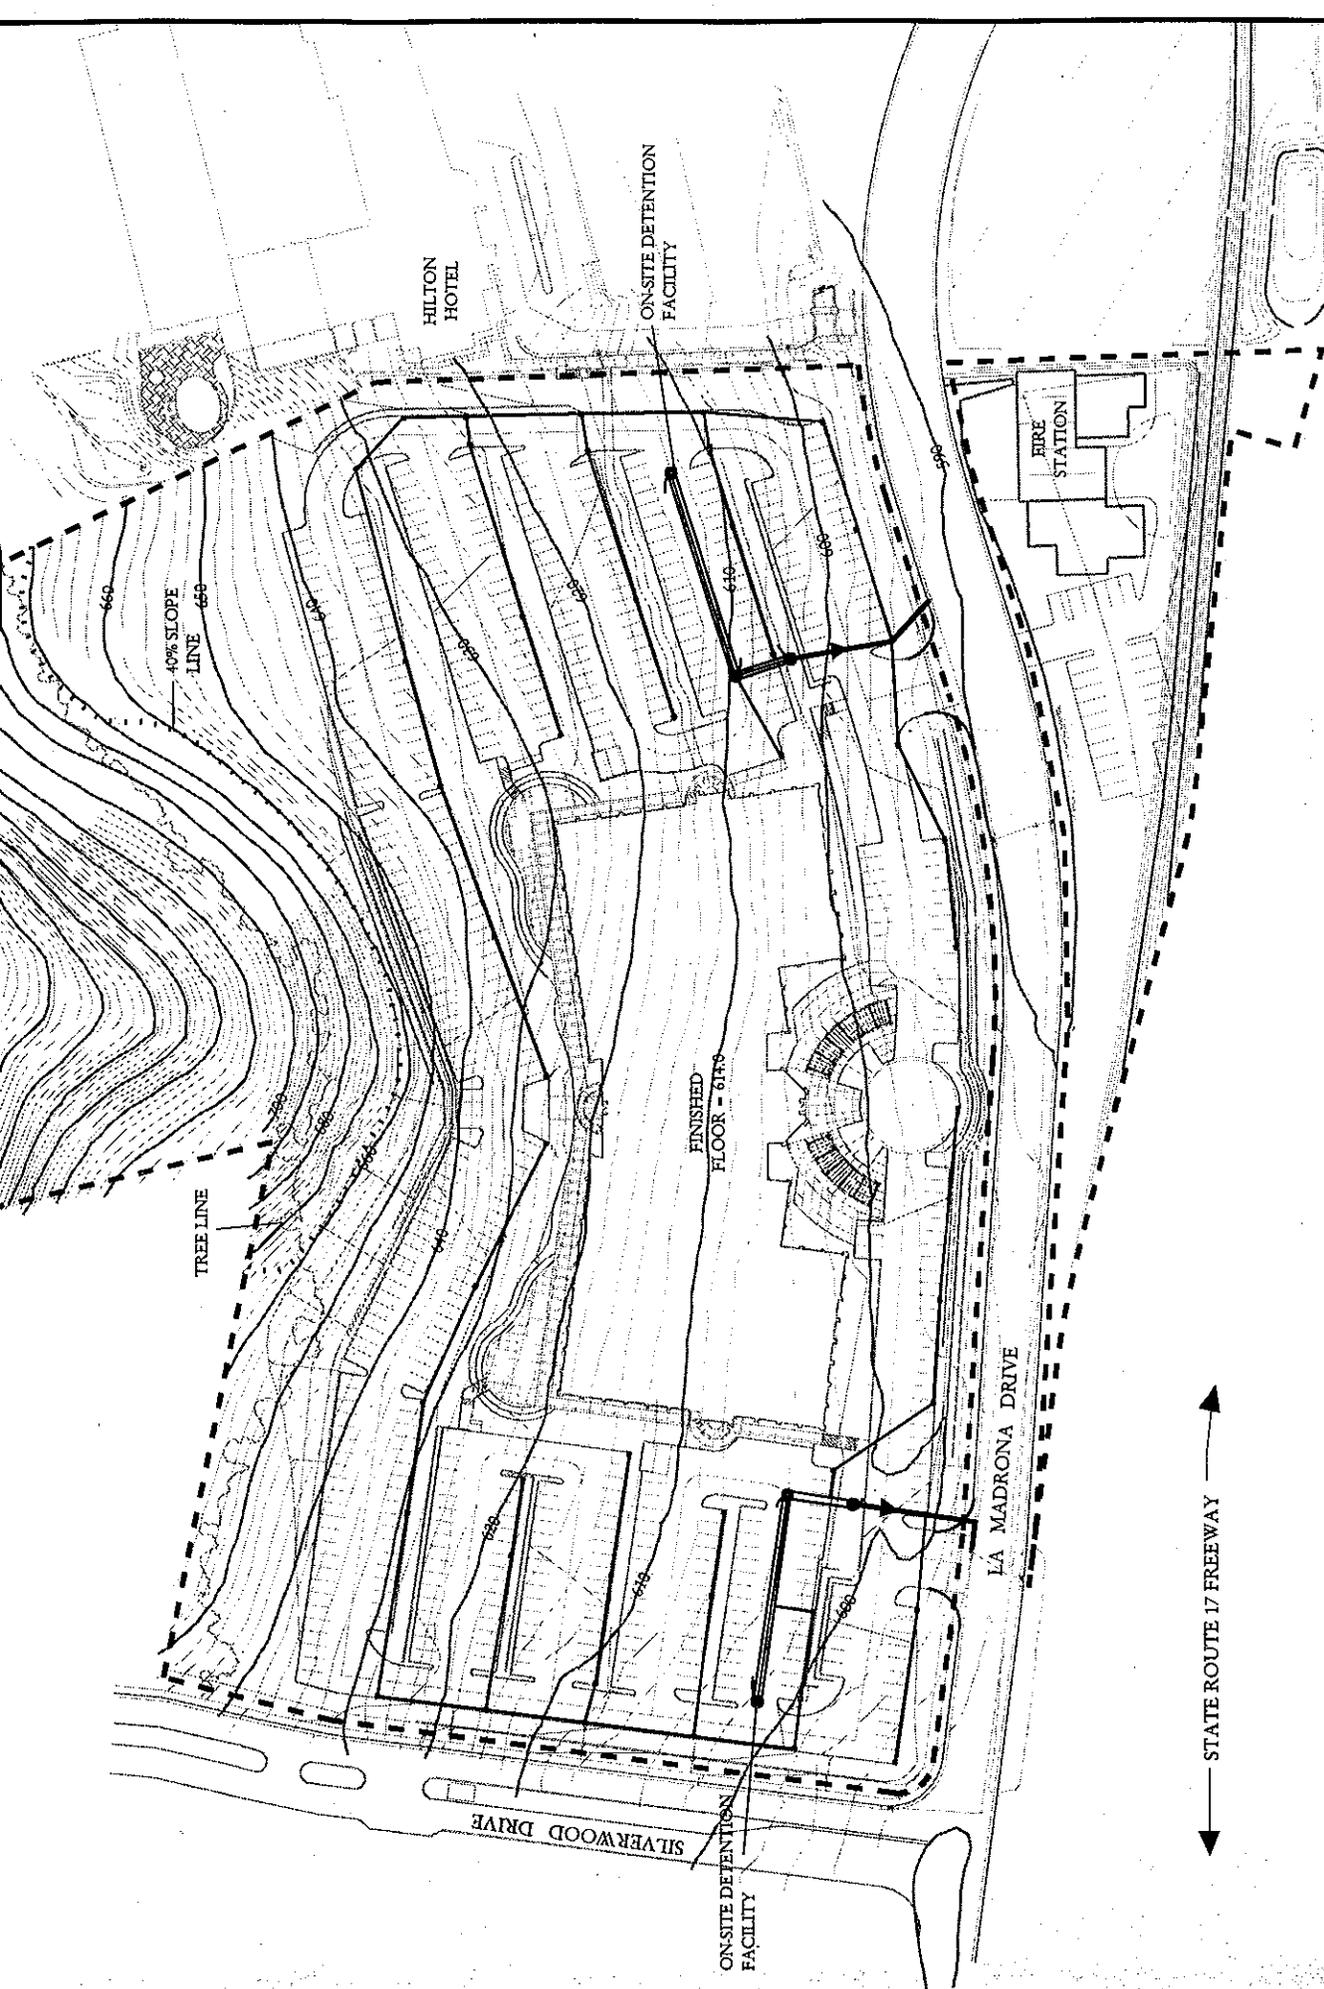
FIGURE 2: DRAINAGE PLAN
 Gateway South Office Building
 and Fire Station
 Scotts Valley, CA

$$Q = (0.9)(1.8)(11.5) + (0.3)(0.96)(7.6) = 22.7 \text{ cfs}$$

Storm Drain Pipe
 or Channel
 Property Line
