Scotts Valley Town Center Specific Plan Area

Delineation of Waters of the United States And State of California

Rincon Consultants, Inc.
1530 Monterey Street, Suite D
San Luis Obispo, California 93401

August 2008

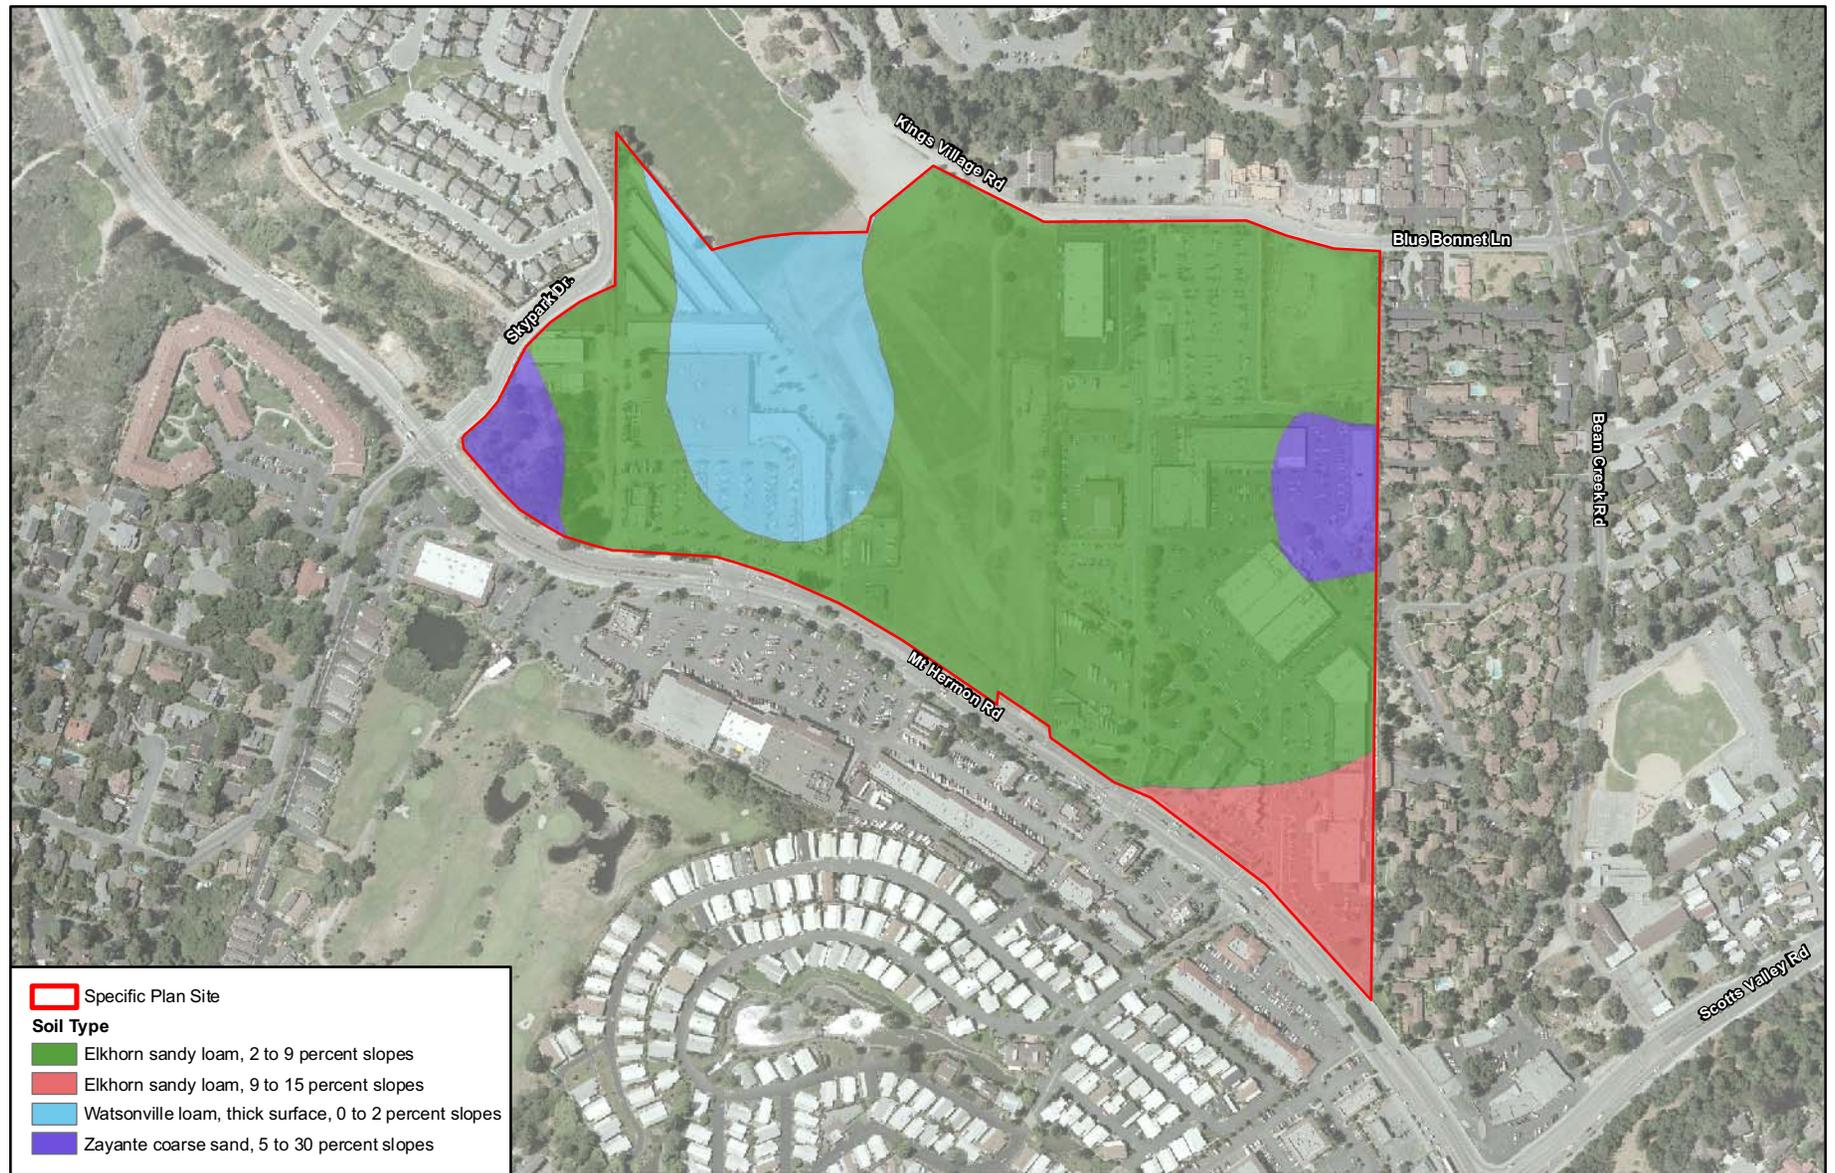
USDA Soil Map

The USDA identifies four soil mapping units within the specific plan area and include: (1) Elkhorn sandy loam, 2-9% slopes; 2) Elkhorn sandy loam, 9-15% slopes; 3) Watsonville loam, thick surface, 0-2% slopes; and 4) Zayante coarse sand 5-30% slopes (please refer to Appendix B). Three of these, which include the Elkhorn sandy loam, 2-9% slopes, Watsonville loam, and Zayante coarse sand, occur within undeveloped portions of the study area, and only two of these were evaluated in this study. The following provides a brief overview of these soil mapping units:

- **Elkhorn sandy loam, 2-9% slopes** is a very deep, well drained soil on old alluvial fans and marine terraces. Areas of other loamy soils such as Baywood and Pinto are typically included in this mapping unit. This soil has moderate shrink-swell potential and has moderately slow permeability. It is the most common soil mapping unit onsite, with the majority already developed.
- **Watsonville loam, thick surface, 0-2% slopes** is also a very deep somewhat poorly drained soil on coastal terraces, formed in alluvium. Permeability is very slow and water may be perched above a clay subsoil. This soil mapping unit occurs in the northwestern portion of the site, which includes the upper reach of the drainage ditch that was the focus of this investigation.

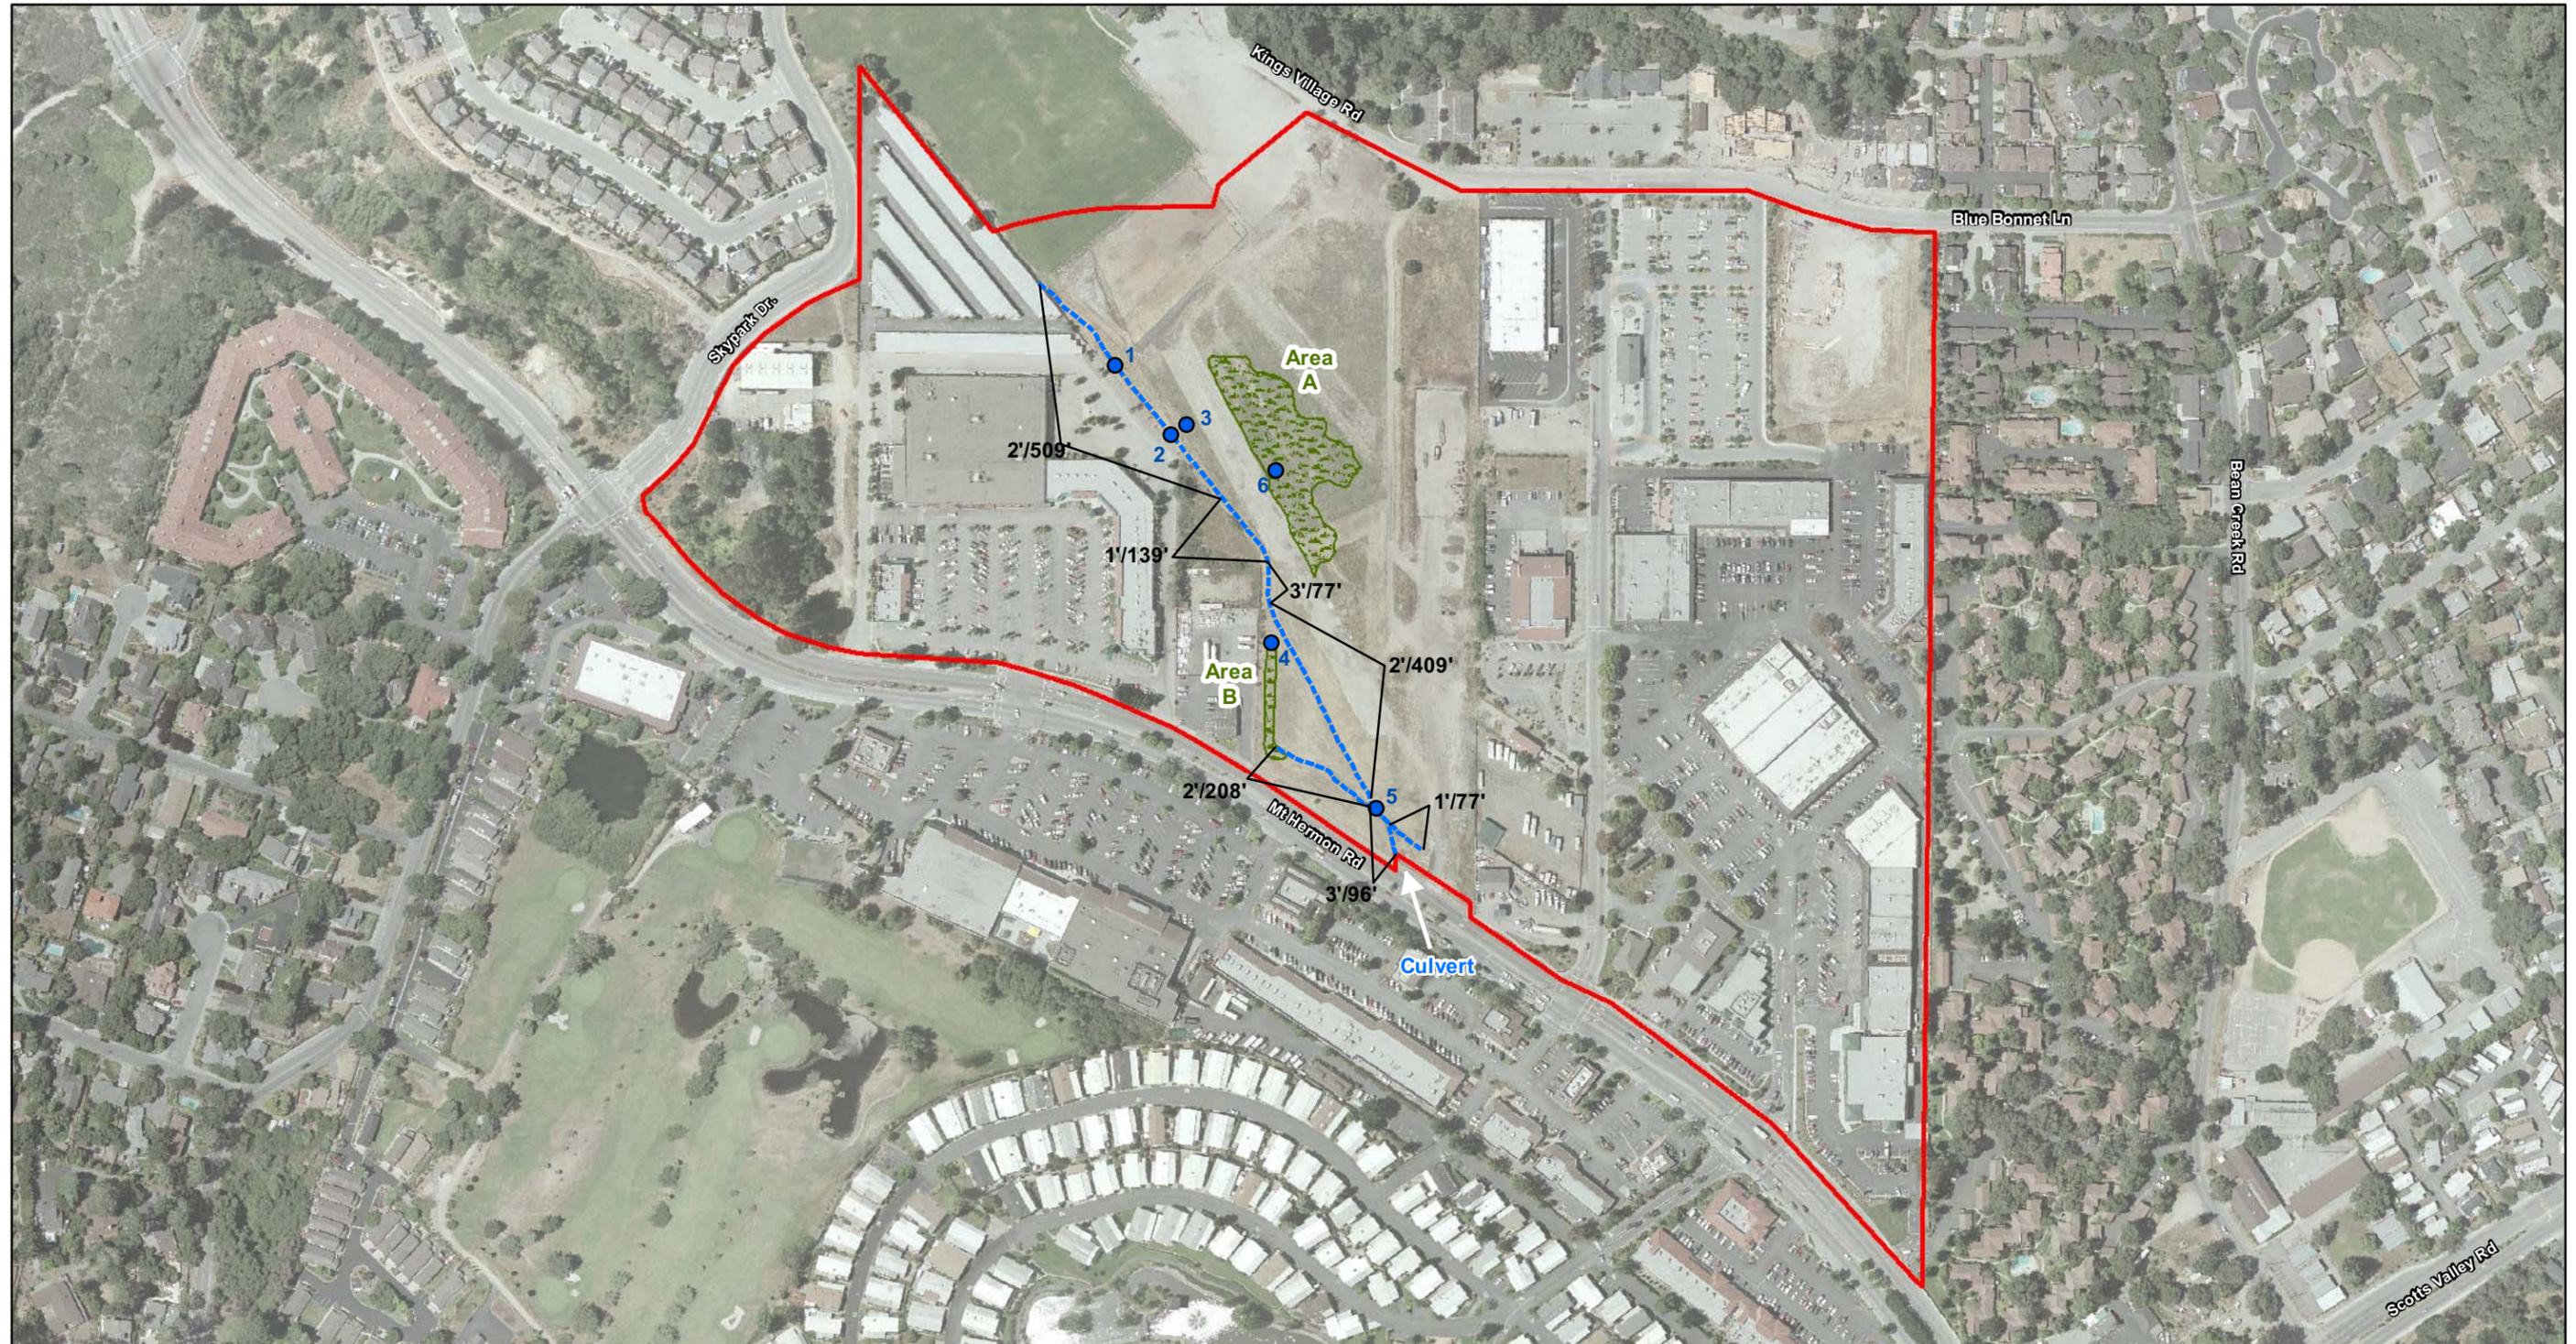
Appendix D
Wetland Delineation Map

- Specific Plan Site
- Seasonal Wetland
- Drainage Ditch (0.07 Acre)
- Data Point Location
- Area A (0.92 Acre)
- Area B (0.09 Acre)
- > Jurisdictional Width/Length' (in feet)

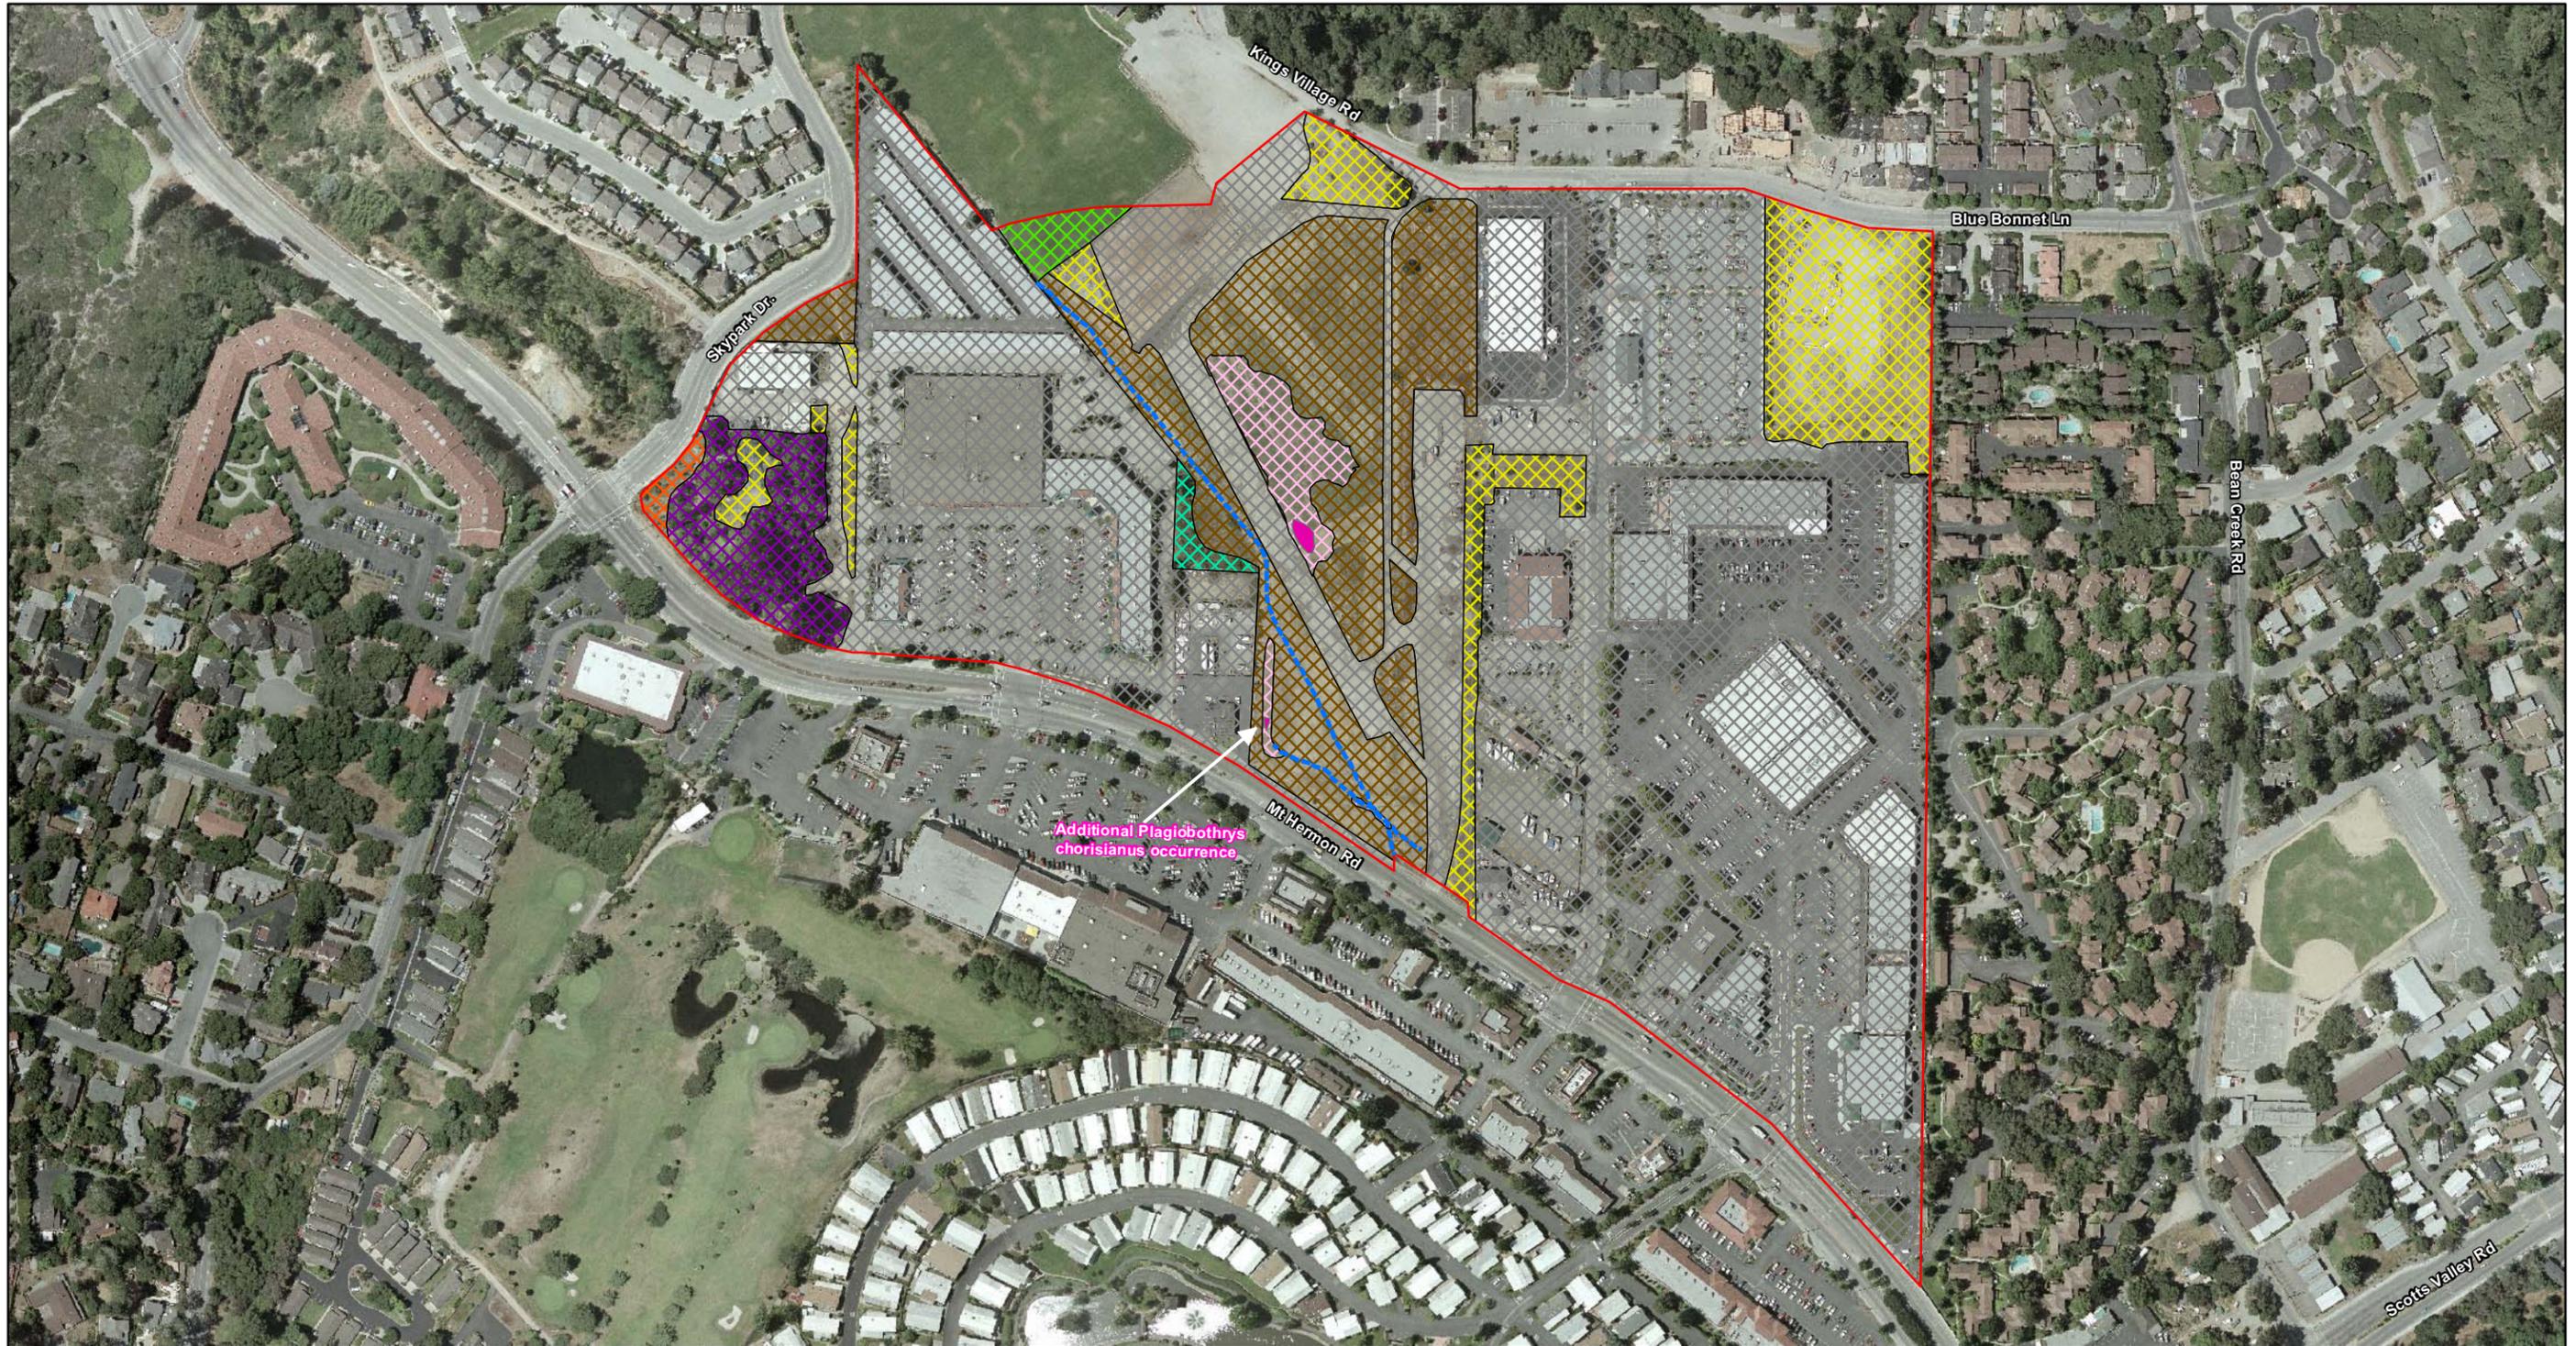
The property is composed primarily of developed and ruderal habitat types, but also includes annual grassland, vernal moist grassland, mixed woodland and coyote brush scrub (please refer to the Habitat Map included as Appendix E). Areas identified as potential "waters" included the drainage ditch and vernal moist grassland areas shown on the Habitat Map. The vernal moist grassland onsite contains a diverse palette of native herbaceous wetland species, such as California oat grass (*Danthonia californica*), brown-headed rush (*Juncus phaeocephalus*), dense flowered sedge (*Carex densa*), and toad rush (*Juncus bufonius*). In addition, an obligate wetland species, Choris' popcorn flower (*Plagiobothrys chorisianus*) is also present in the topographic low areas identified as Areas A and B on the Wetland Delineation Map included in Appendix D. The vernal-moist grassland areas are likely remnants of the dominant native vegetation type that occurred in the Scotts Valley area and on the historic Skypark airport prior to development of the area.

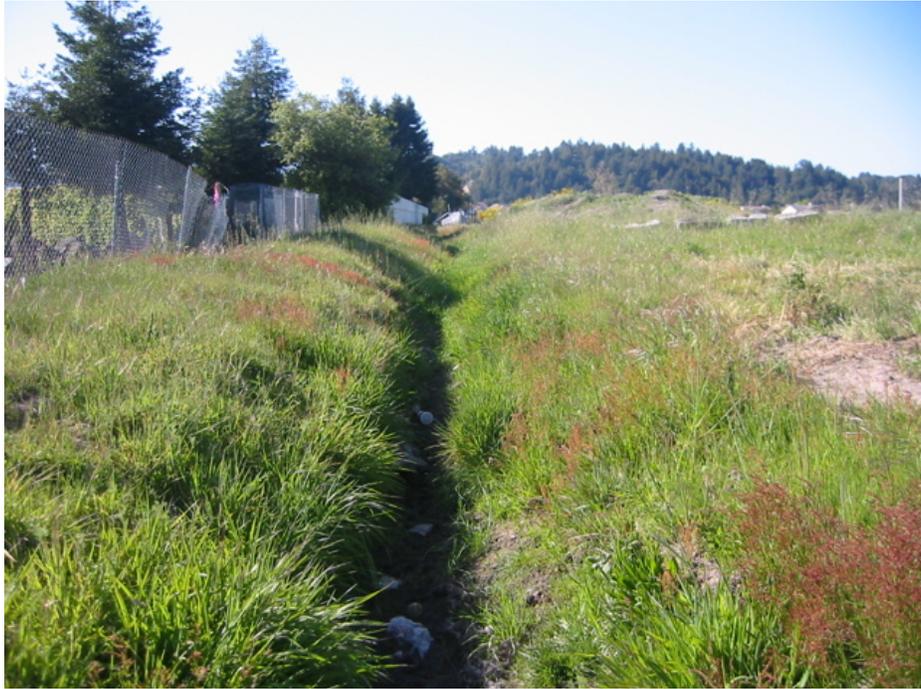
Photo Point 1. Northwesterly view of the middle portion of the drainage ditch. The width of the ditch in this location averages from one to three feet wide.

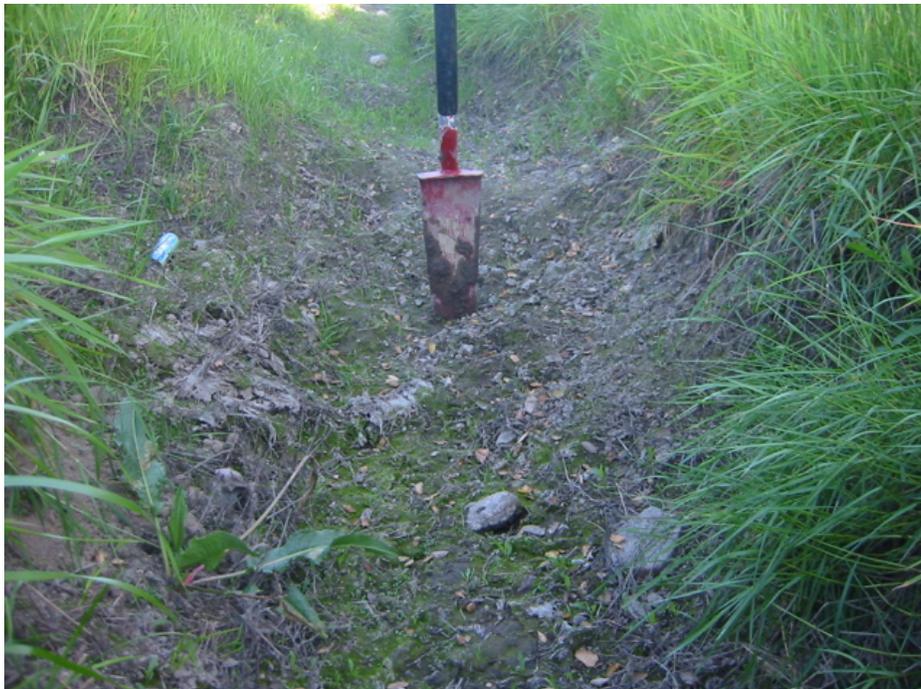
Photo Point 2. Southeasterly view of the bed of the ditch in the vicinity of Data Point 2 as shown on the Wetland Delineation Map.

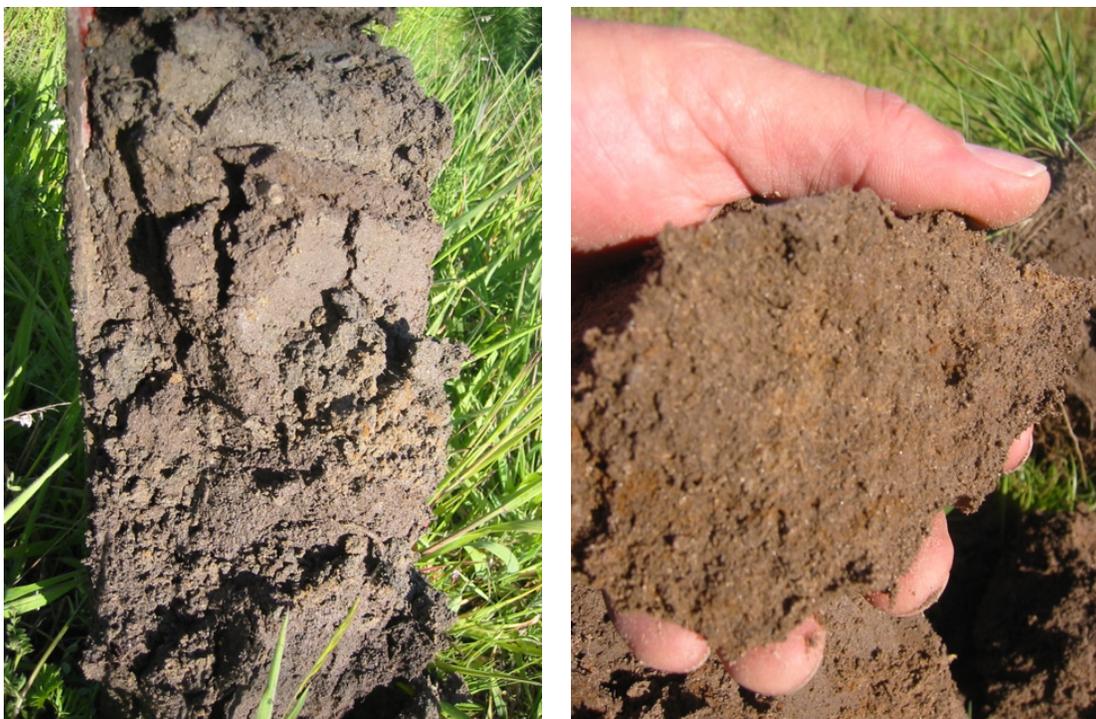
Photo Point 3. Soils from Data Point 2. Note the dark surface layer approximately 2 inches thick (10YR2/1) and the lighter B horizon (10YR3/2) with redoximorphic features visible (7.5YR5/6).

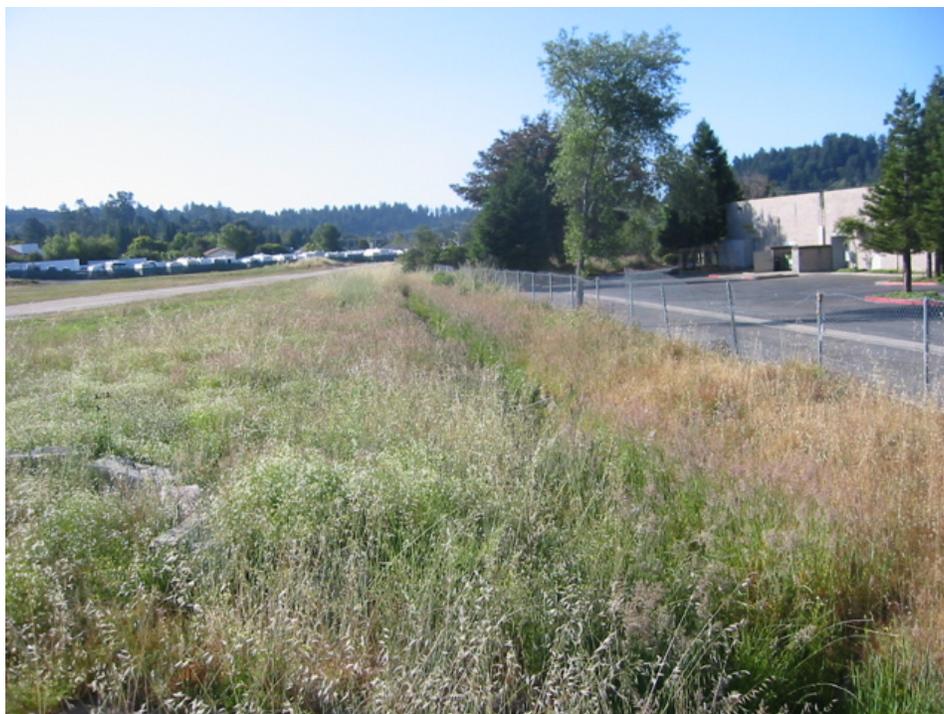
Photo Point 4. Southeasterly view of the drainage ditch from the vicinity of Data Point 2. This photo was taken in June 2008. Note the channel vegetation is still green compared to surrounding upland vegetation.

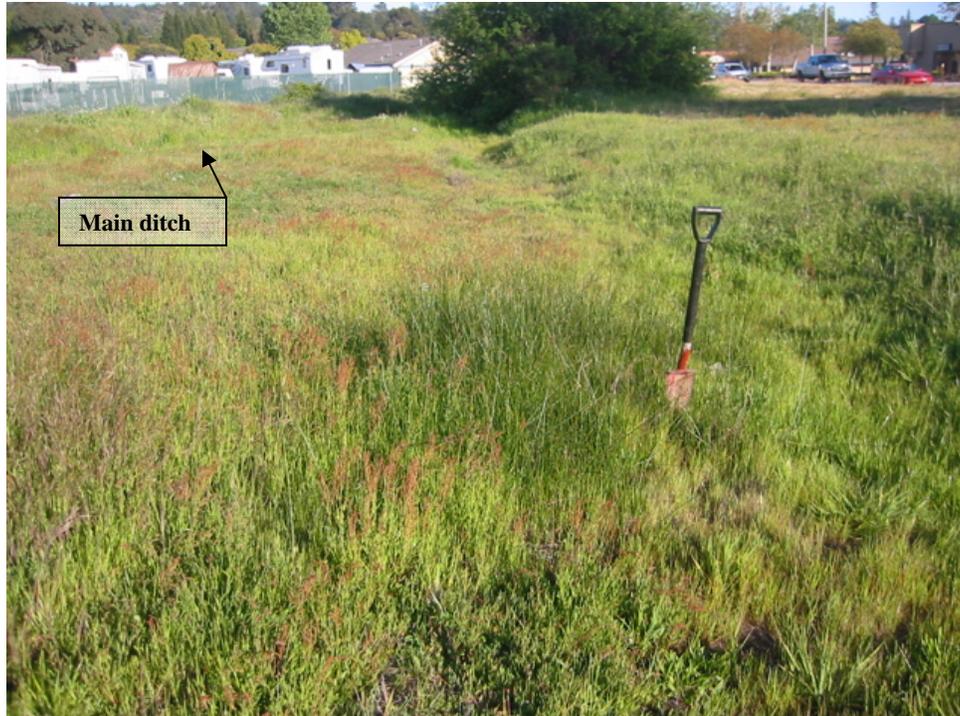
Photo Point 5. Easterly view of seasonal wetland within a small drainage ditch connected to the main drainage ditch. This area receives surface runoff from surrounding property to the west as well as overflow from the main drainage. This photo was taken south of Data Point 4 near the 90-degree turn upstream from Data Point 5 as shown on the Wetland Delineation Map.

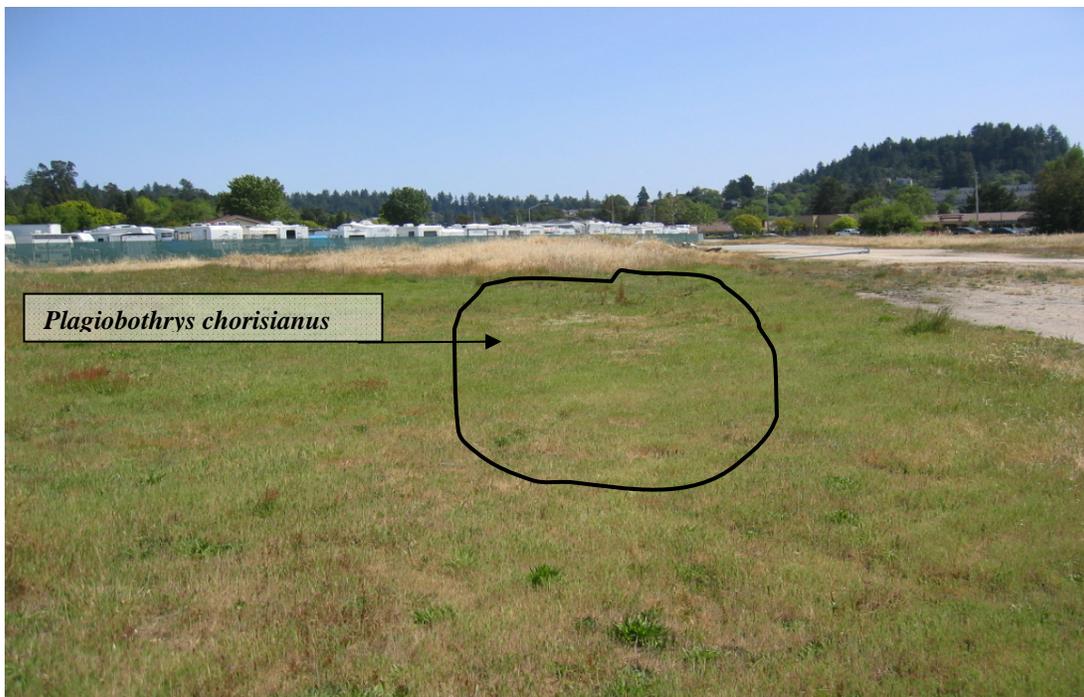
Photo Point 6. Southeasterly view of the seasonal wetland area characterized by Data Point 6. Occurrence of *Plagiobothrys chorisianus* is visible as small white patches in the center of the photo. Surface flows are apparently impounded by the runway visible on the right side of the photo.

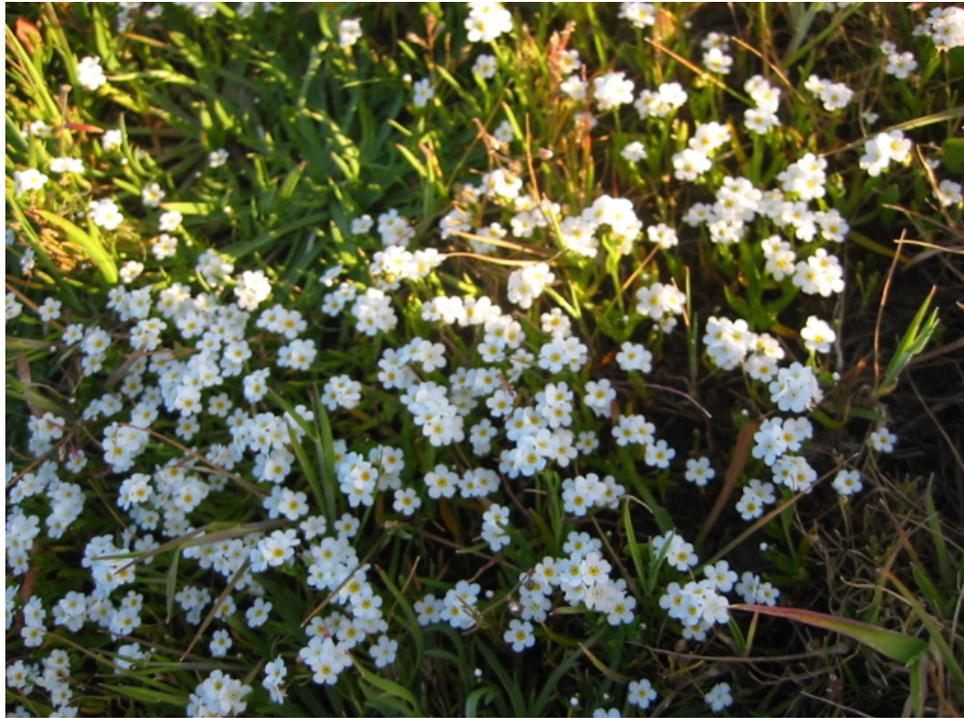
Photo Point 7. Close up photograph of *Plagiobothrys chorisianus* onsite taken during the April 2008 field work.

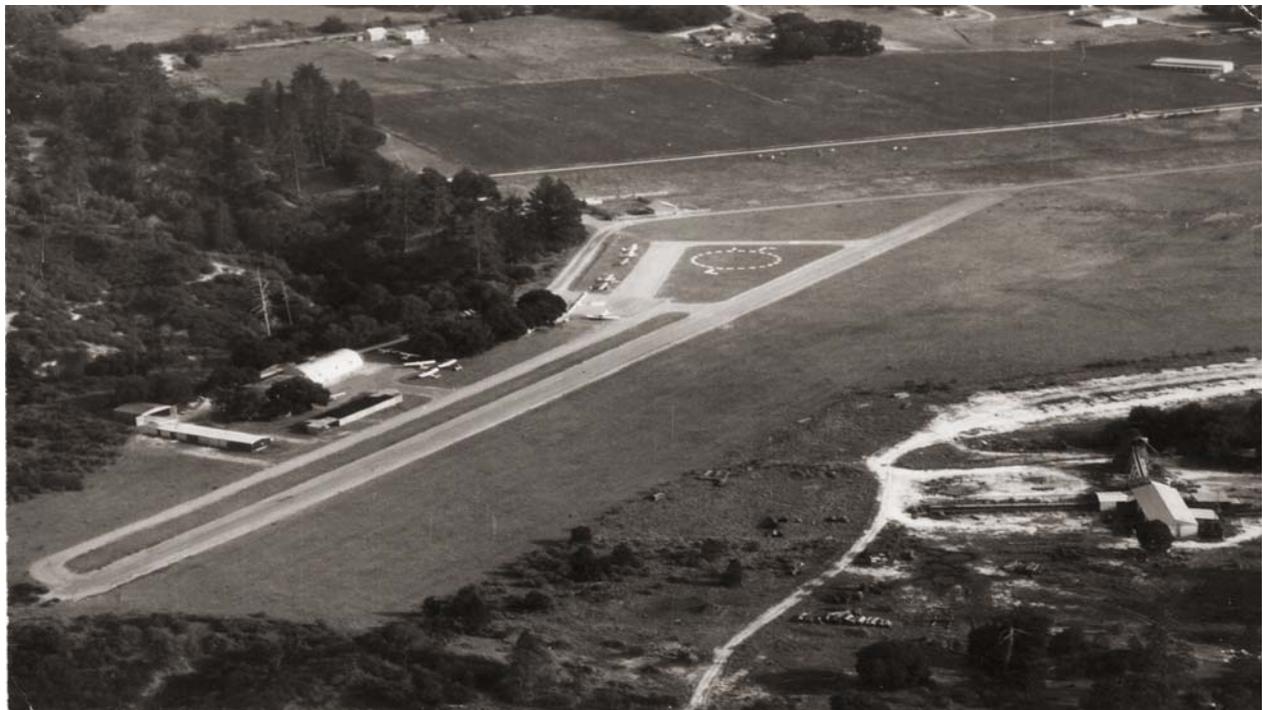
Photo Point 8. Historic aerial photograph of the former Skypark Airport. No distinct natural drainage feature is apparent onsite.
