### *Phase I Environmental Site Assessment*

# Phase I Environmental Site Assessment

**Scotts Valley Town Center  
Scotts Valley, California**

Rincon Consultants, Inc.  
April 25, 2008

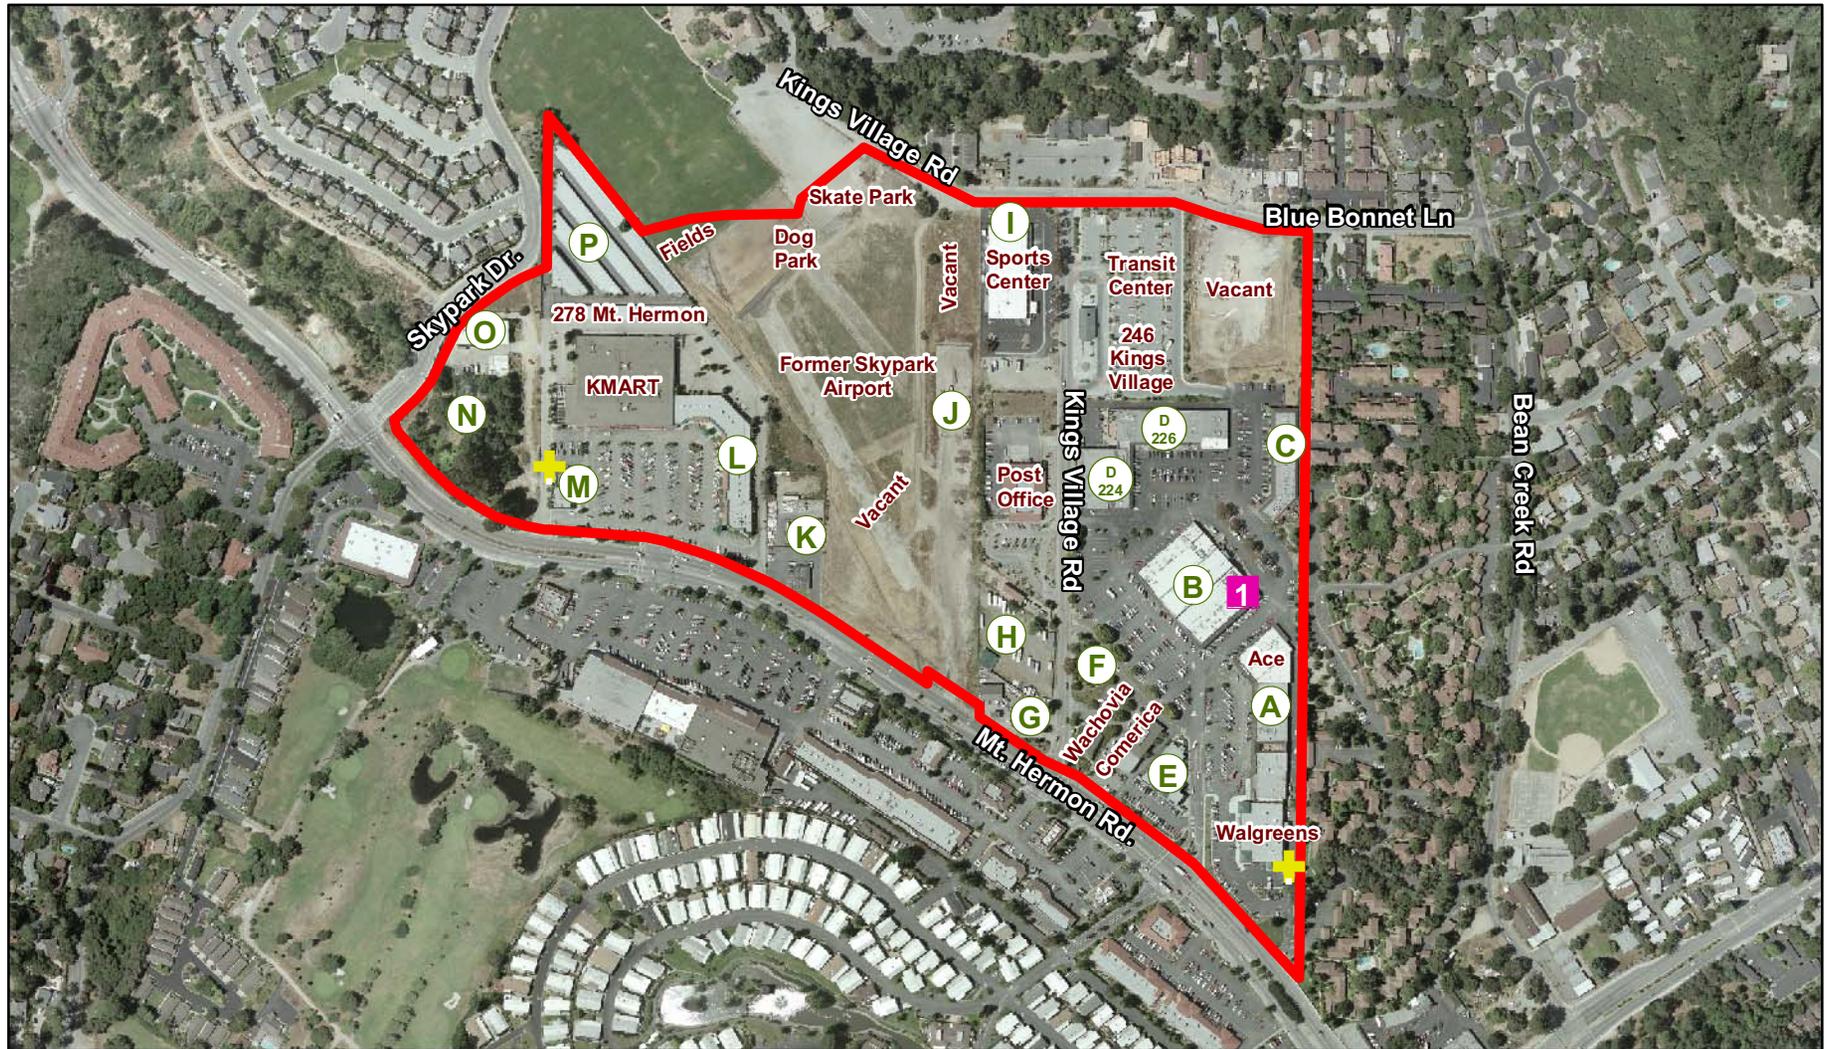
Figure 2  
 City of Scotts Valley

- % Areas Detailed on Table 1
- 1 Kings Cleaners Location
- + Locations of Remediation Compounds

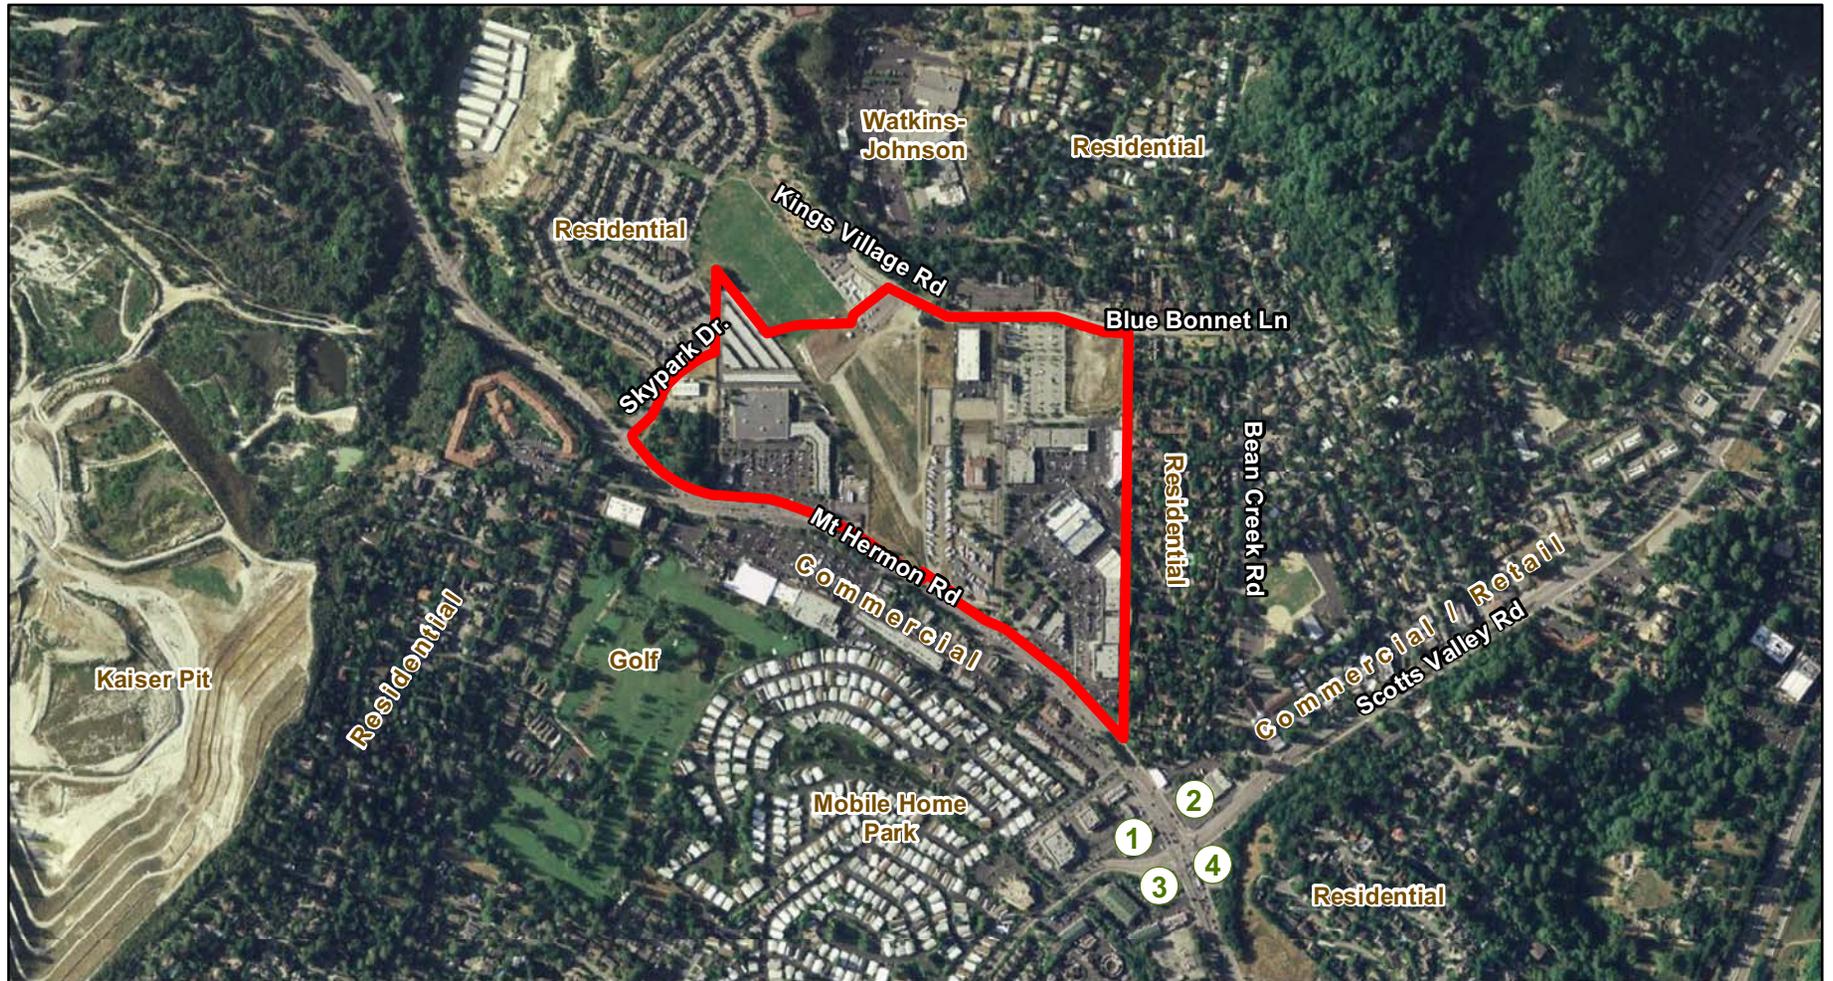
Figure 3  
 City of Scotts Valley

- ① Former BP Gasoline Service Station
- ② Former Chevron Gasoline Service Station
- ③ Existing Unocal Gasoline Service Station
- ④ Existing Shell Gasoline Service Station

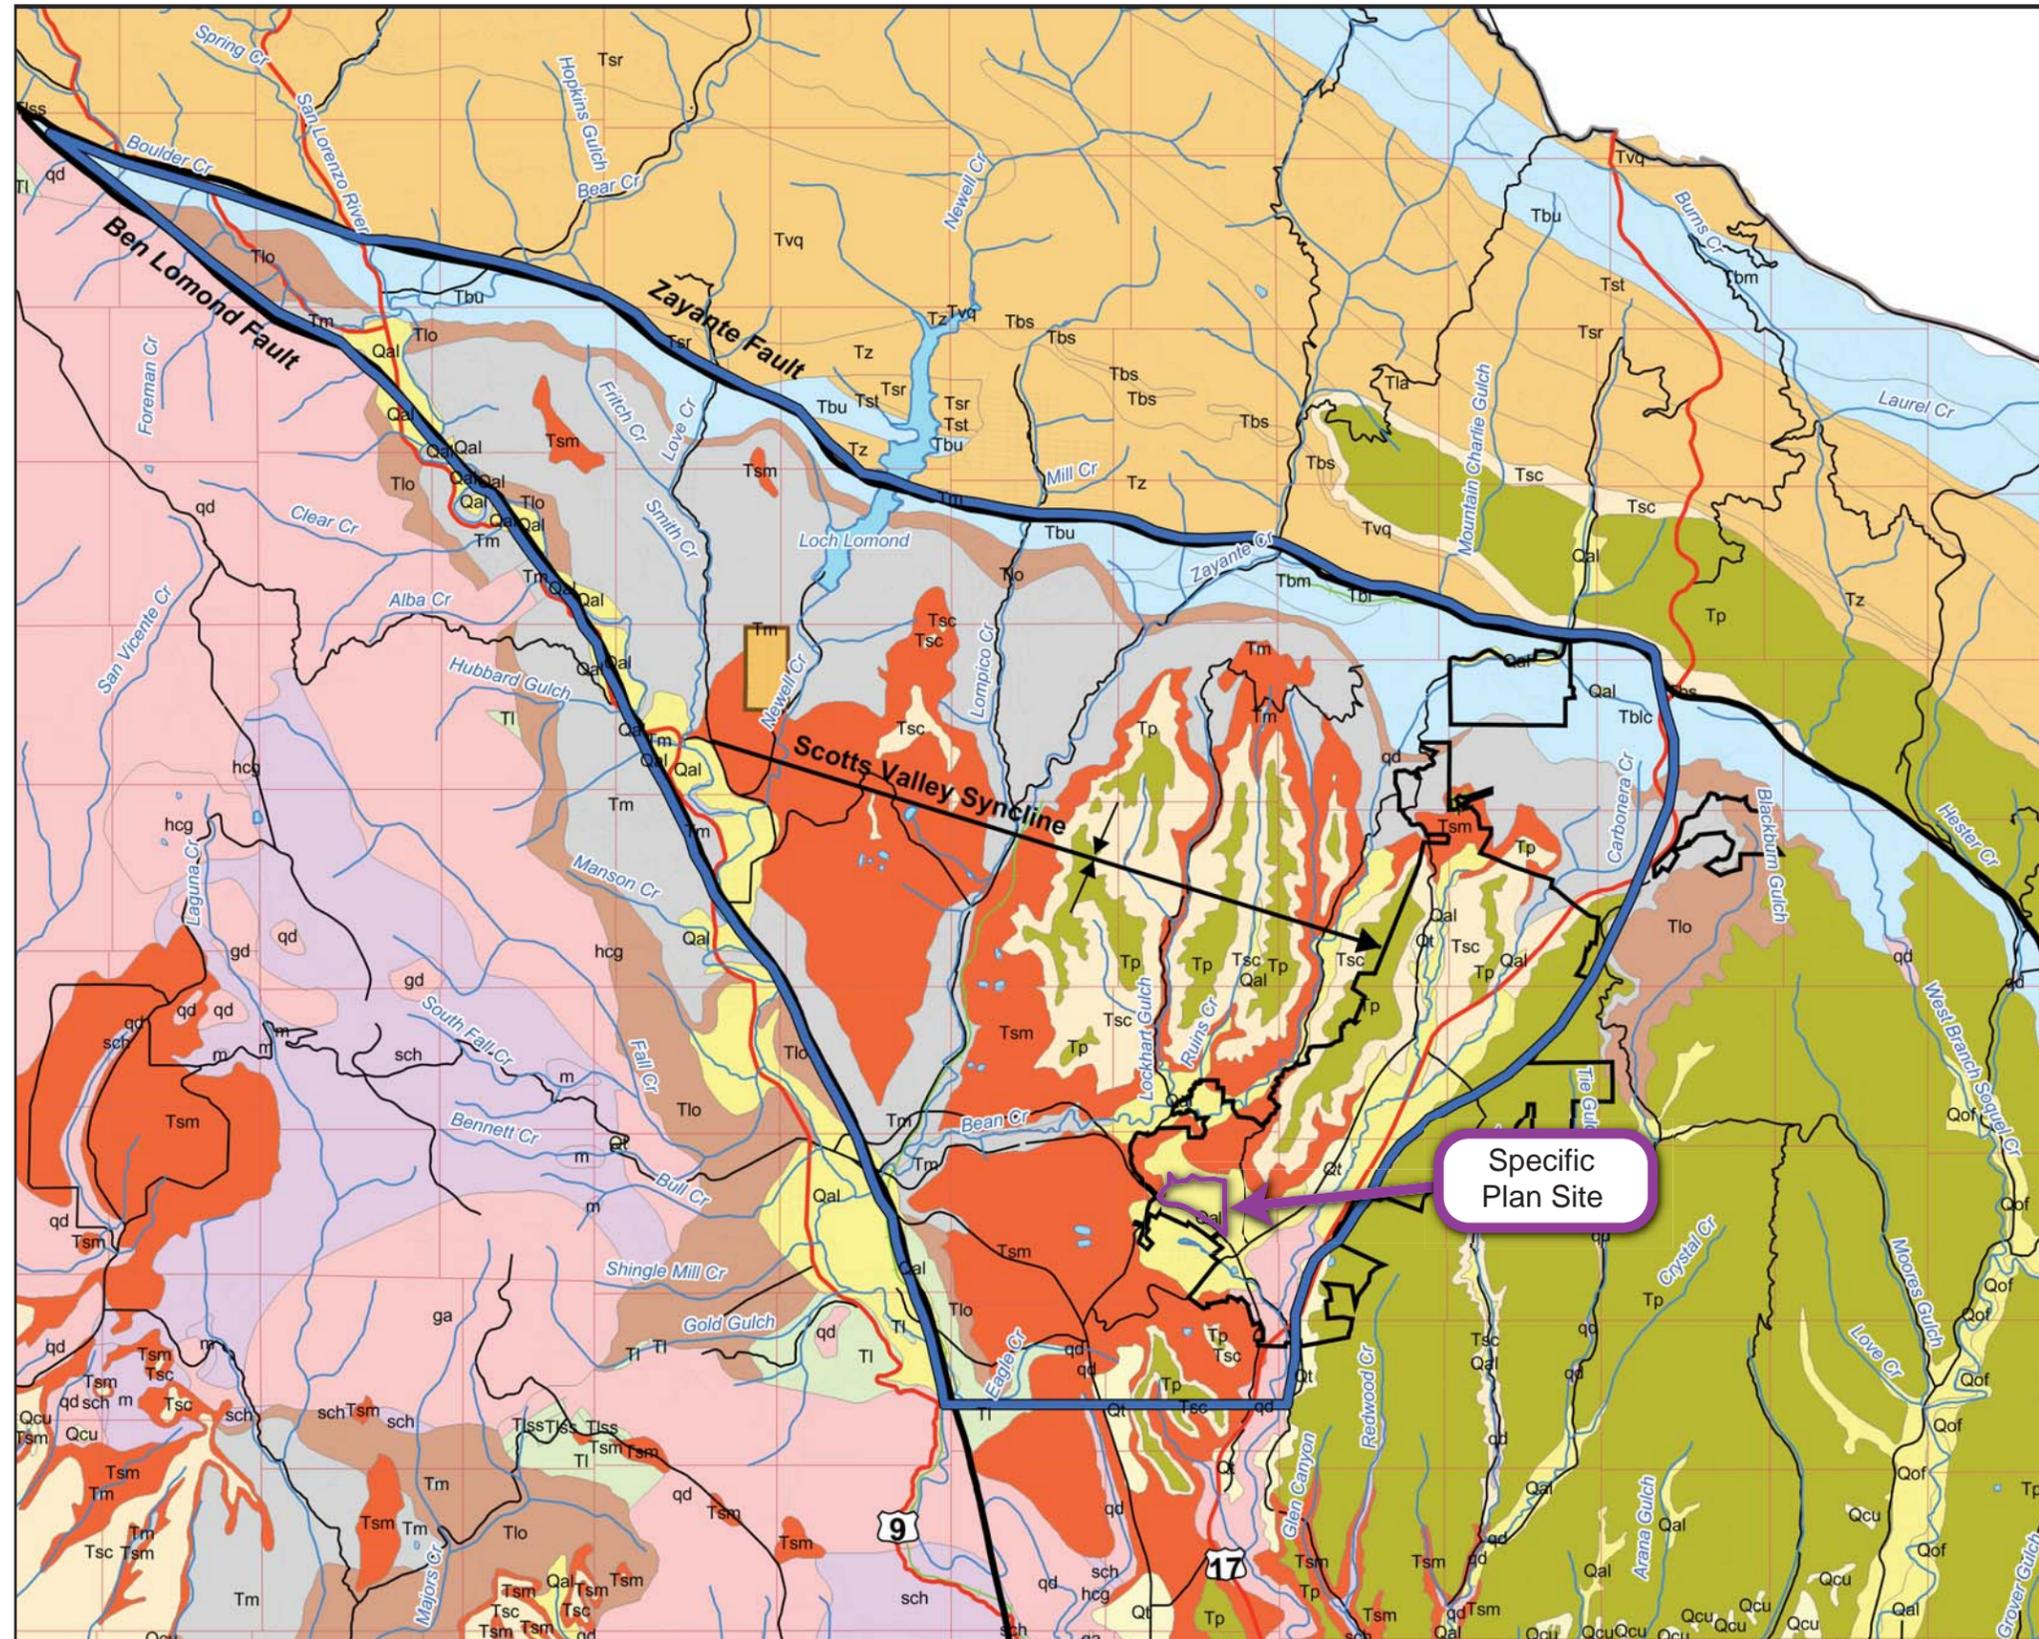
Scotts Valley Geologic Map  
 Figure 4  
 City of Scotts Valley

Legend	
[Yellow]	Alluvium
[Light Yellow]	Marine Terrace
[Green]	Purisima Formation
[Orange]	Santa Cruz Mudstone
[Red]	Santa Margarita Sandstone
[Grey]	Monterey Formation
[Brown]	Lompico Sandstone
[Light Orange]	Zayante, San Lorenzo, Vaqueros and Lambert Formations
[Light Blue]	Butano Formation
[Light Green]	Locatelli Formation
[Pink]	Granite
[Purple]	Metasedimentary
[Blue outline]	Santa Margarita Groundwater Basin
[Black outline]	Scotts Valley Water District

The Locatelli Formation is only found in the South Scotts Valley area and is comprised of erosional remnants of a gray, sandy siltstone with a sandstone bed typically found at the base of the unit. The Butano Sandstone consists of sandstone and interbeds of mudstone, shale and siltstone of Eocene geologic age. The Lompico Sandstone is a 200- to 300-foot thick sandstone unit that forms the base of the middle Miocene geologic aged sequence. The Monterey Formation is primarily composed of mudstone, shale and siltstone of middle Miocene geologic age. The Santa Margarita Sandstone generally consists of massive, fine- to medium-grained sandstone of upper Miocene geologic age. The Santa Margarita Sandstone forms a distinctive formation of white and yellow sand that can be observed in cliffs around the area. The Santa Margarita Sandstone is a significant drinking water source for the area and occurs at the surface over a large portion of the upland areas, from the south of Scotts Valley to the Quail Hollow area near Ben Lomond. In the northern Scotts Valley the Santa Margarita Sandstone is overlain by either the Quaternary alluvium or the Santa Cruz Mudstone.

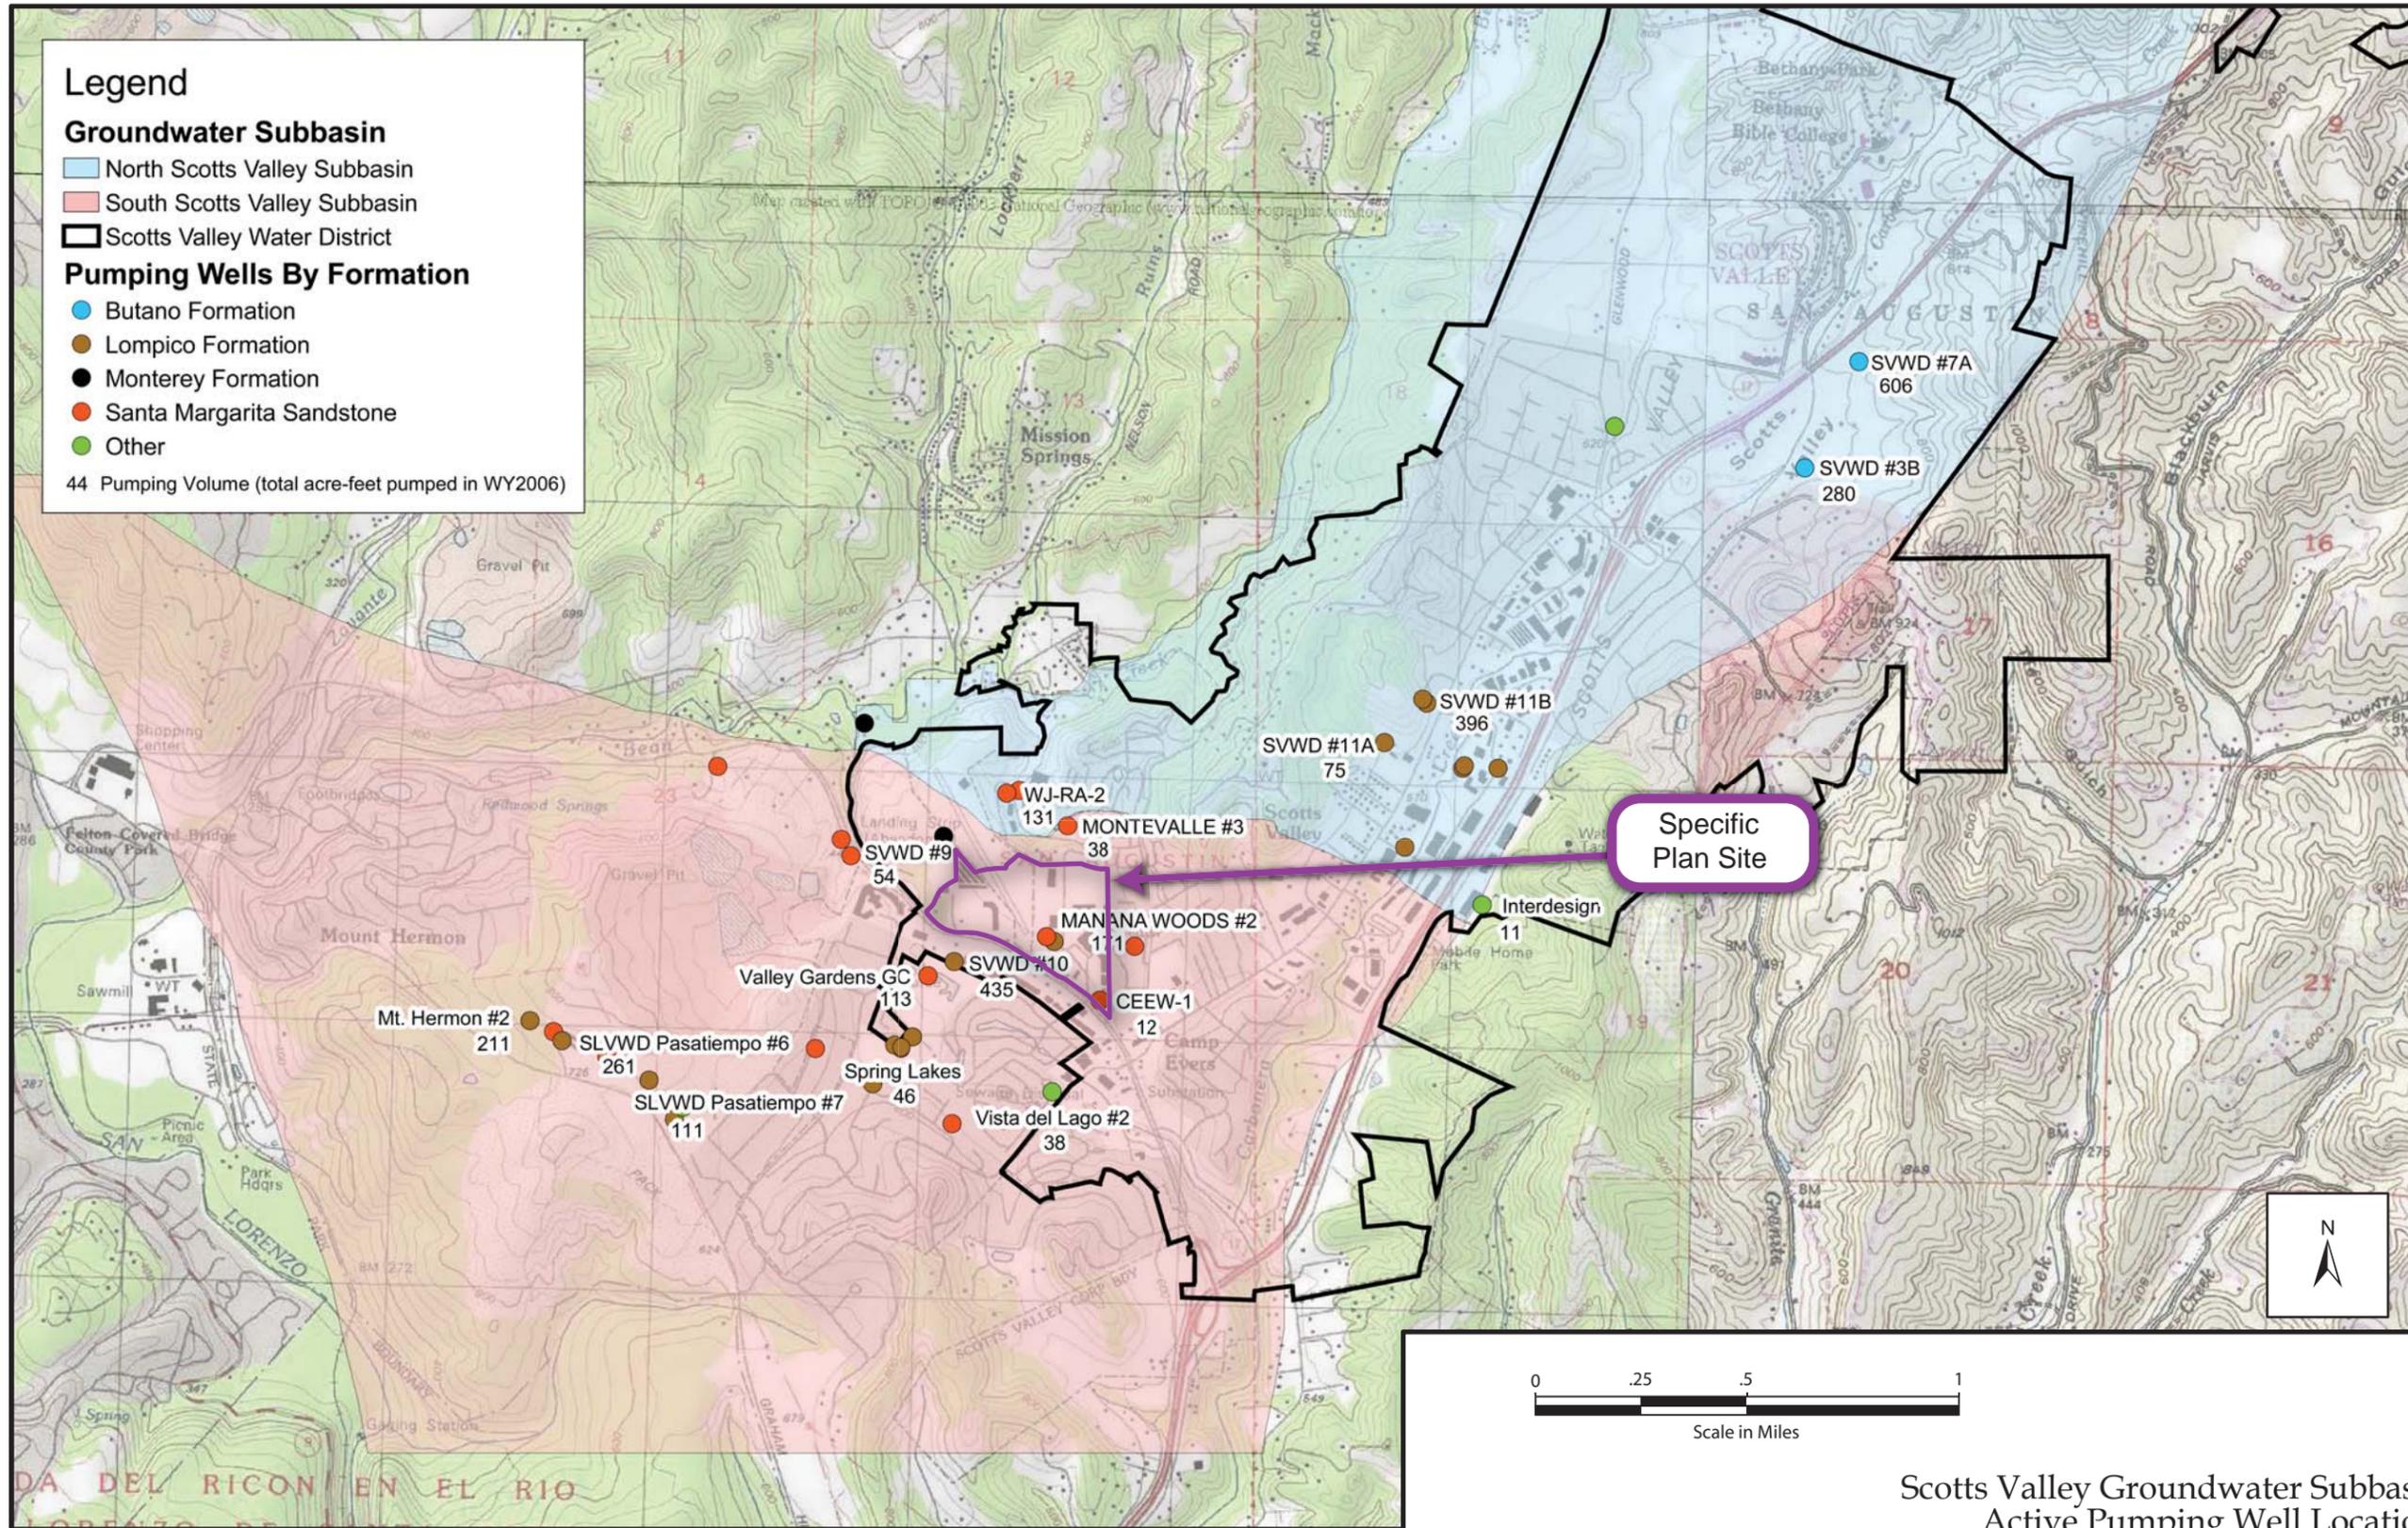
Scotts Valley Groundwater Subbasins and Active Pumping Well Locations

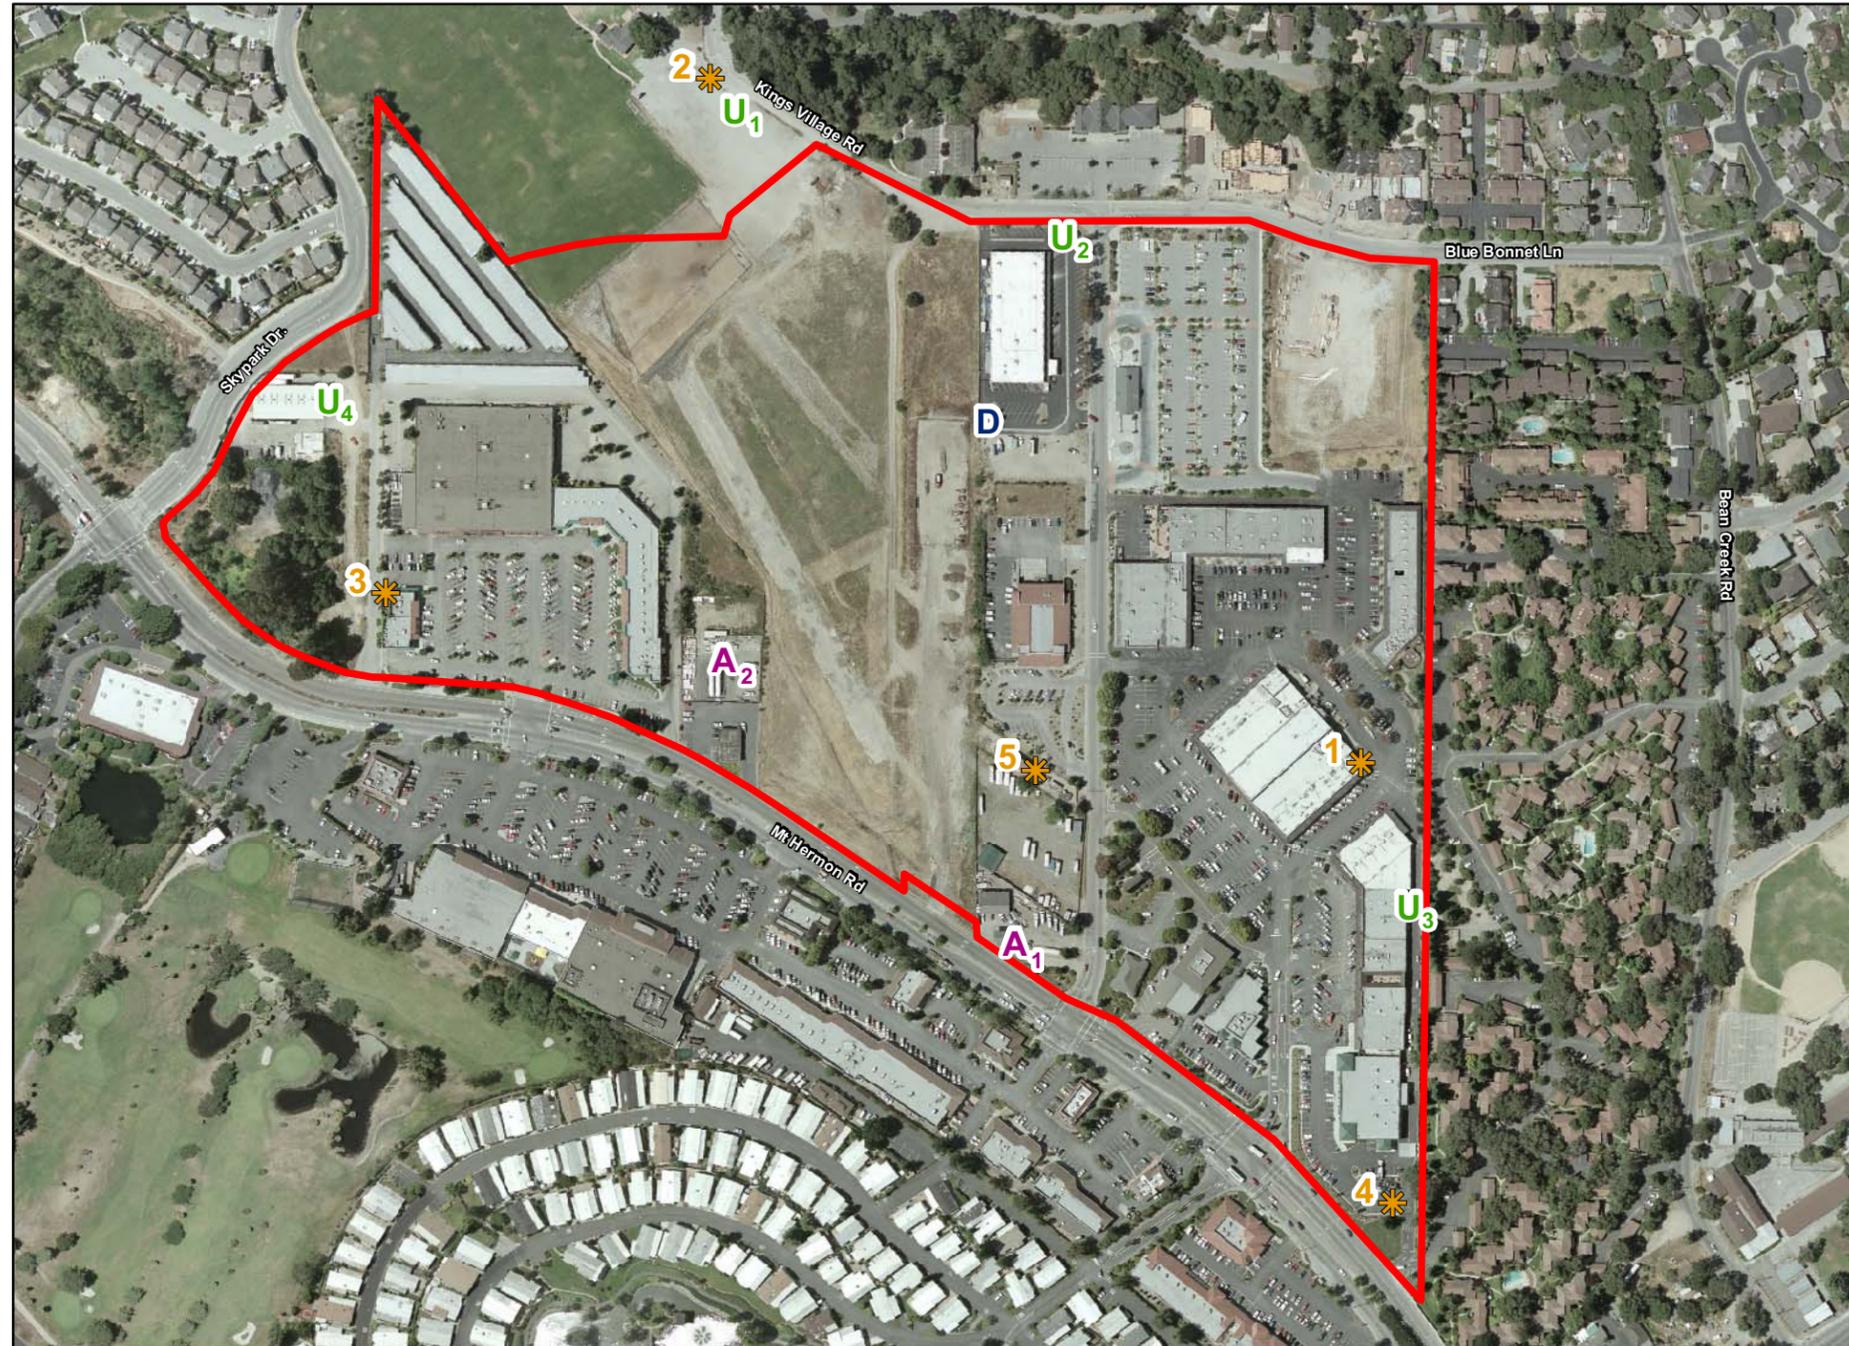
Areas of Environmental Concern  
Scotts Valley Town Center

- U<sub>4</sub>** Suspect UST at Former Wescosa site. No detailed information identified or reported.
- 1** Kings Cleaners: Drycleaners since 1969.
  - 2** Watkins – Johnson: Approximate Location of Groundwater monitoring well WJ-41 that had PCE and TCE concentrations in groundwater in the First Quarter of 2006 (Arcadis, April 27, 2006).

- 3** Scotts Valley Cleaners and Associated Remediation Compound.
  - 4** Camp Evers Plume Remediation Compound and Extraction Well
  - 5** Mañana Woods Municipal Groundwater Treatment Facility

Approximate Limits of Camp Evers Plume and Scotts Valley Cleaners Plume are shown on Figure 6.

- A<sub>1</sub>** Above-ground propane tanks, AmeriGas
- A<sub>2</sub>** Above-ground propane tanks, Suburban Propane
- D** Two 55-gallon drums in Parking Lot of Sports Center

The owner of the Sports Center should be contacted and questioned regarding the contents of the two unlabeled drums in the Sports Center parking lot. If the contents are known and not hazardous, then the drums should be removed and properly disposed. If the contents are unknown, then an environmental consultant capable of sampling and identifying the drum contents should be contracted to properly dispose of the drums. The drums should be disposed prior to redevelopment or grading activities.

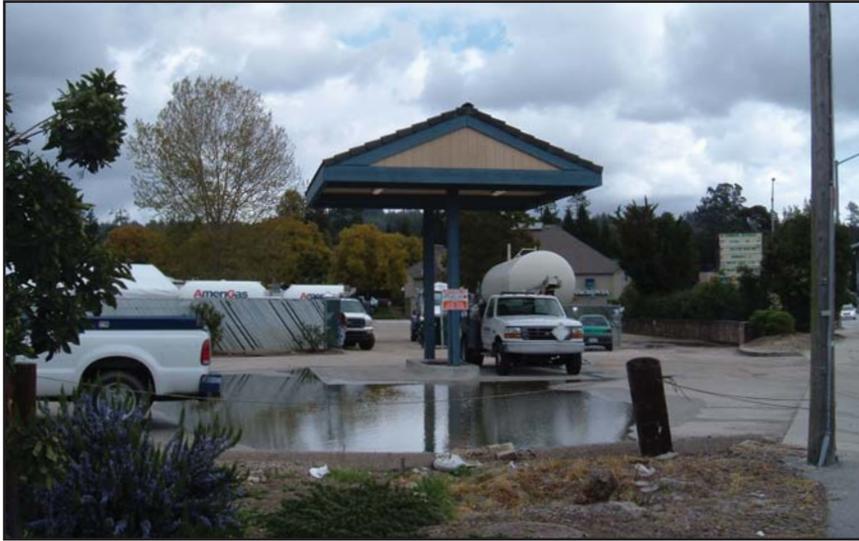
Photo Point 9: Area G - AmeriGas.

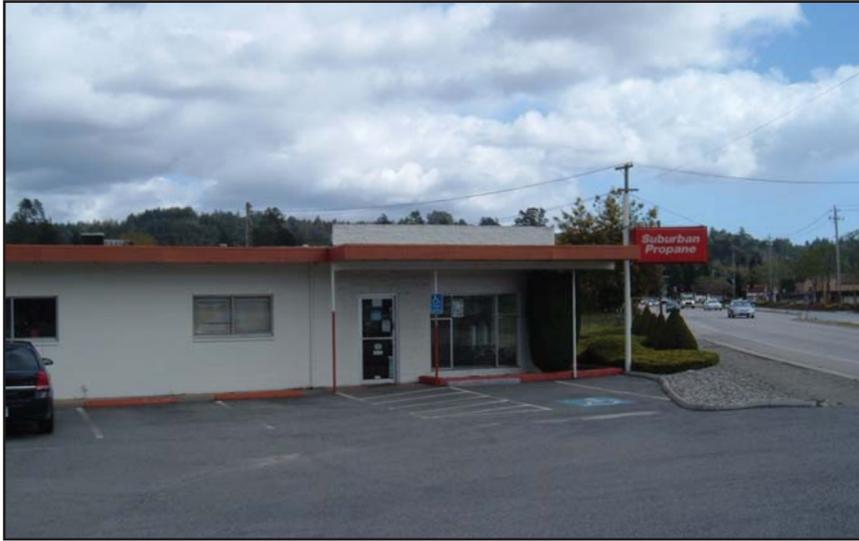
Photo Point 13: Area K - Suburban Propane.

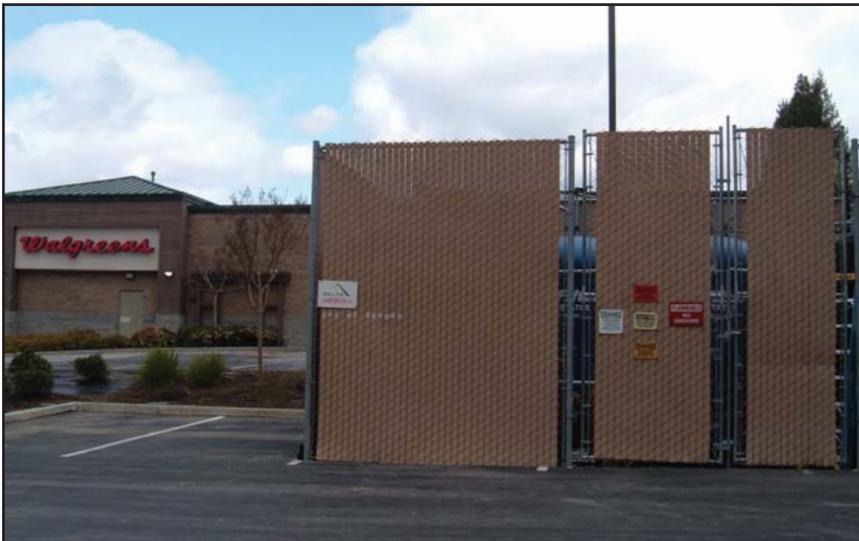
Photo Point 27: Remediation compound - 200 Mt. Hermon.

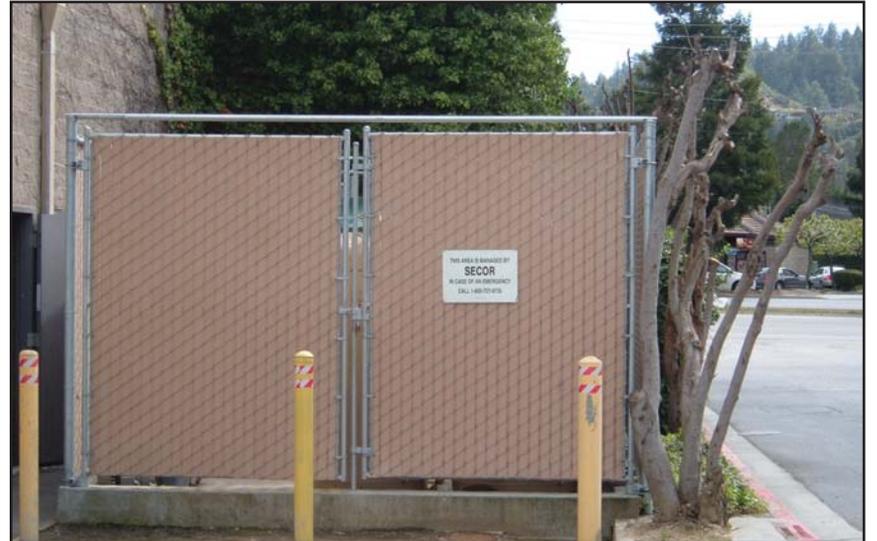
Photo Point 28: Remediation compound behind Scotts Valley Cleaners Area M.

In June of 2002, the RWQCB approved a Pilot Test Workplan submitted by SECOR for the site. The Pilot Test Workplan included the installation of injection wells for bioremediation. By January of 2003, SECOR concluded that the limited amount of groundwater monitoring data available to date makes identification of chemical trends difficult, and that additional injection events are necessary to promote anaerobic biodegradation.
